Inspection Report

Property Address:
190 Fay Way
Rye Beach New Hampshire 03871

DBC Home Inspections

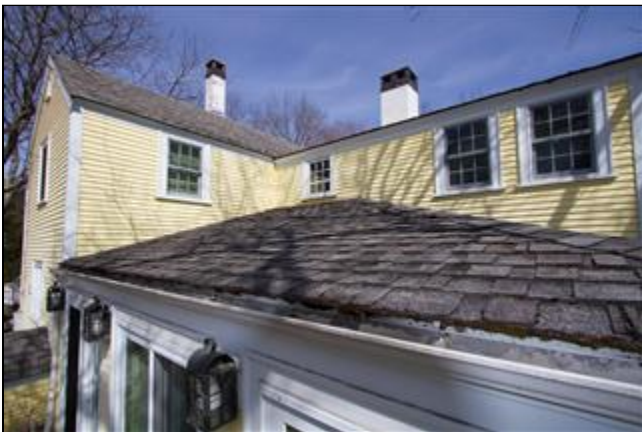
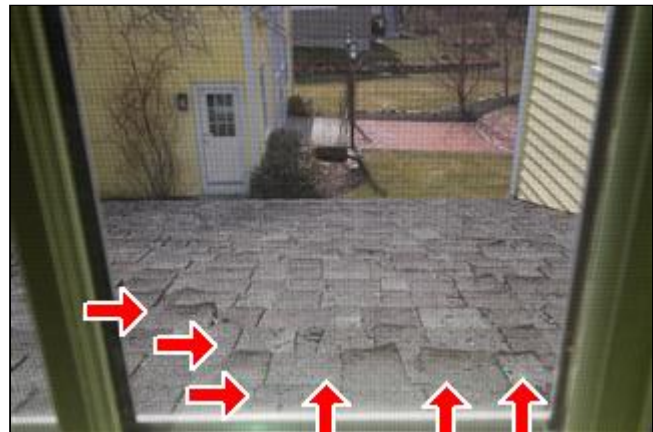
1.0 (1) SUNROOM ROOF: The roof that covers the sunroom is looking warn. The low pitch and New England weather can vastly shorten the life of an asphalt shingle. The homeowner disclosed that the roof is about 13 years old. It has been a hard 13 years- I recommend re-shingling this portion of the roof. Alternative roof coverings such as metal may be a good option for a long term roof covering at such a low pitch. A qualified and insured roofing professional should perform this work.

1.0 Picture 1 Sunroom Roof

1.0 Picture 2 Sunroom Roof

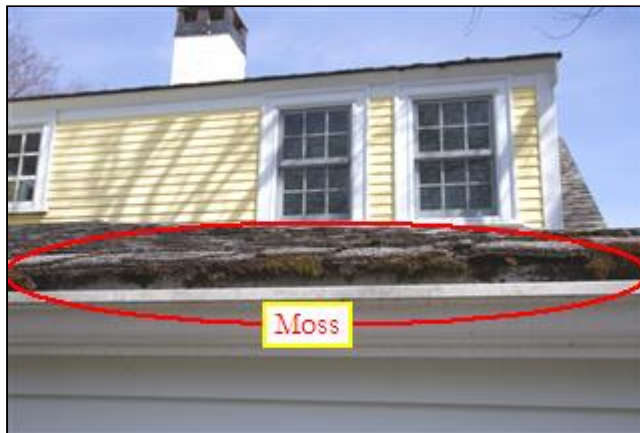
1.0 (2) SUNROOF ROOF: The roof of this historic home utilizes roof shakes as a drip cap- a historic supplement to the standard aluminum drip cap typically seen on homes. The down side to this material is that it can rot and grow moss as seen in this case. Recommend replacing.

1.0 Picture 3 Shake Drip Cap

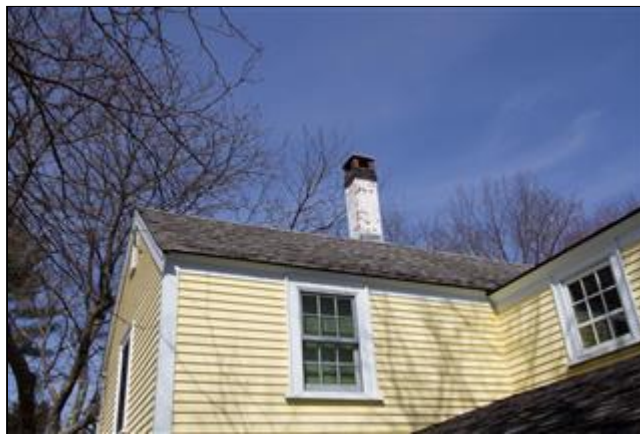
1.0 (3) MAIN HOUSE: The remaining parts of the roof appear in good working shape. The working life of this type of shingle is around 20-25 years- I estimate that this roof MAY last another ten years before it needs to be replaced. As is always the case with roofs: a roof that is in good shape today can be one good storm away from being ruined tomorrow. I advise monitoring roof coverings often and making sure that vegetation and tree limbs are kept clear.

1.0 Picture 4 Upper Roof

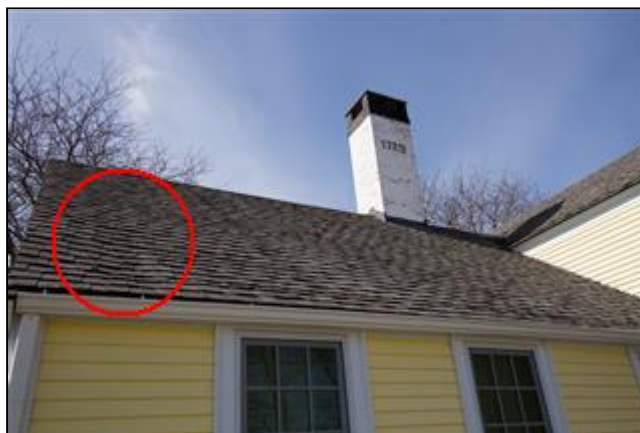
1.0 (4) MAIN HOUSE: The north facing roof has some typical dips for a home this age. No signs of leaking or distress was present on the inside so I would not raise a flag yet. Using the rest of the 2000 restoration of this home I would assume that the entire roof was re sheeted with plywood before the roof shingles were installed.

1.0 Picture 5 North Roof

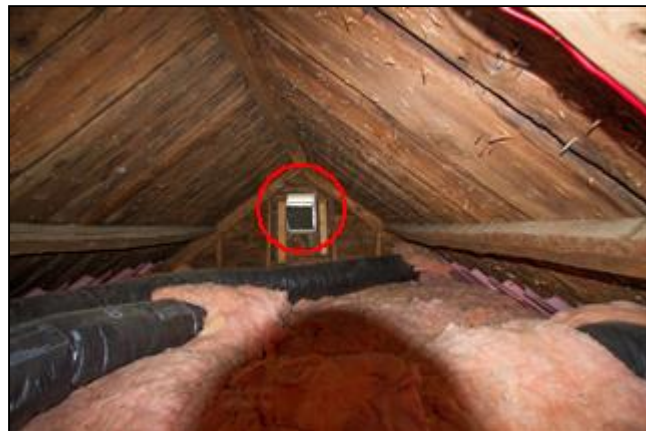
1.3 VENTILATION: The attic space is vented using gable vents. Soffit vent insulation dampers were present in the attic put soffit vents were not visible from the exterior. This style of ventilation is very typical for the a home of this historic age.

1.3 Picture 1 Gable vent

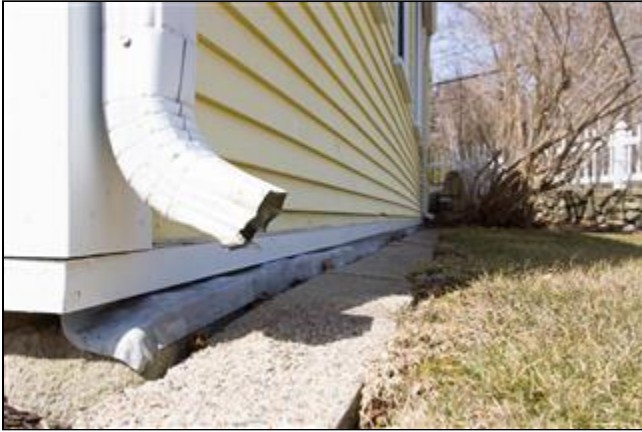
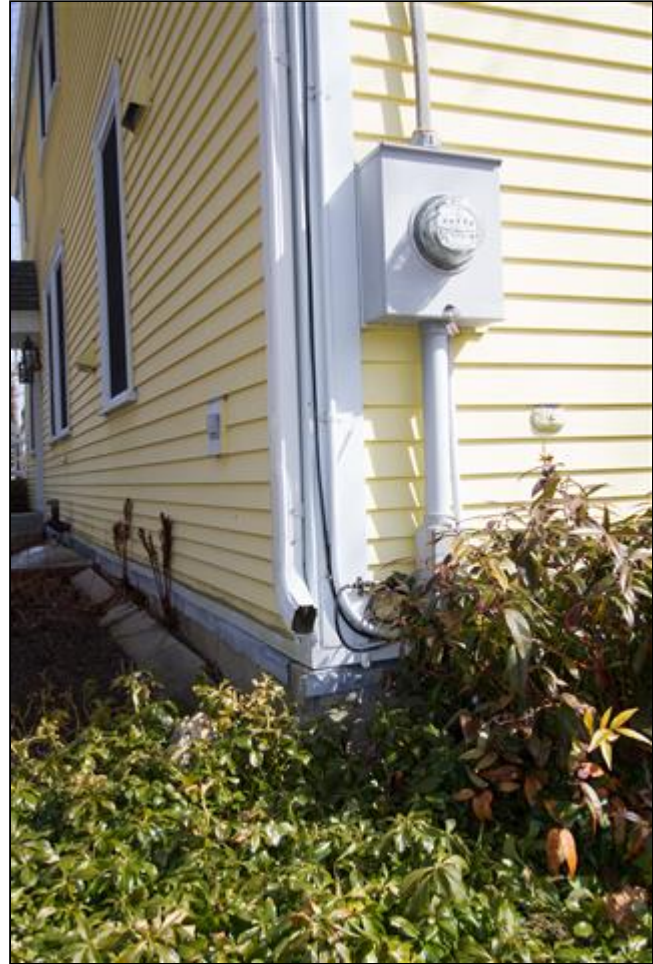
1.4 GUTTERS: Seamless gutters have been installed on this home. They appear clean and in good working order. Managing the outflow of discharged water is important to keeping a dry basement. I would recommend adding lengths of downspout where needed to discharge water as far from the home as possible.

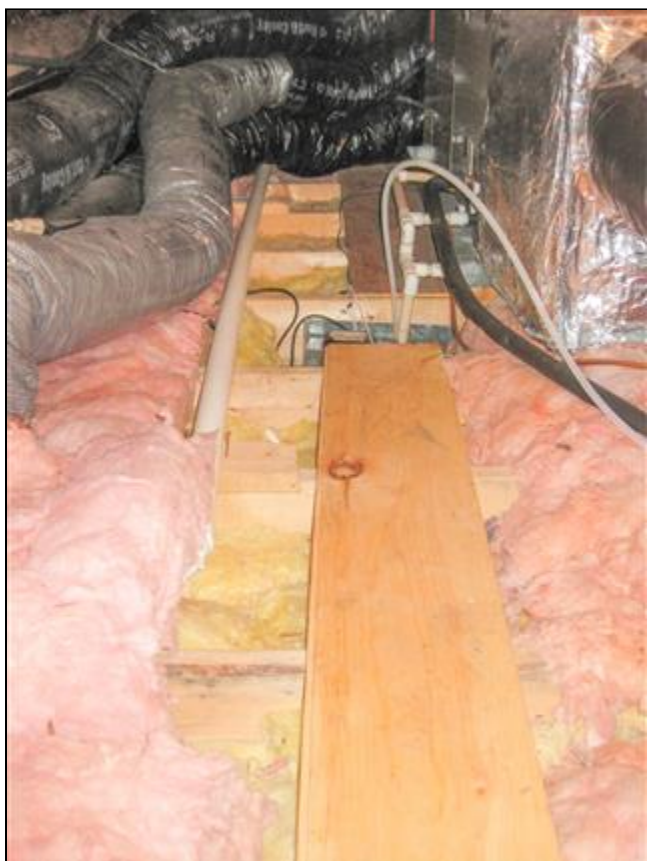
1.7 INSULATION: The insulation is adequate but there is always room for improvement. No visible vapor barrier was observed. A consistent vapor barrier is key for fiberglass insulation to reach its full efficiency.

1.7 Picture 1 Attic Insulation

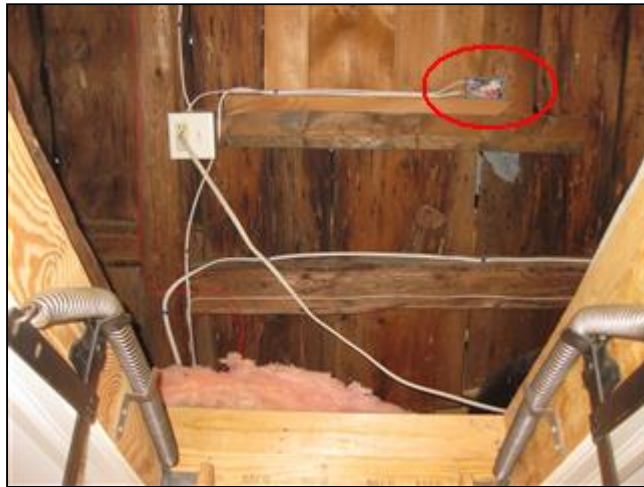
1.8 JUNCTION BOX: Needs cover plate

1.8 Picture 1 Cover Plate Needed

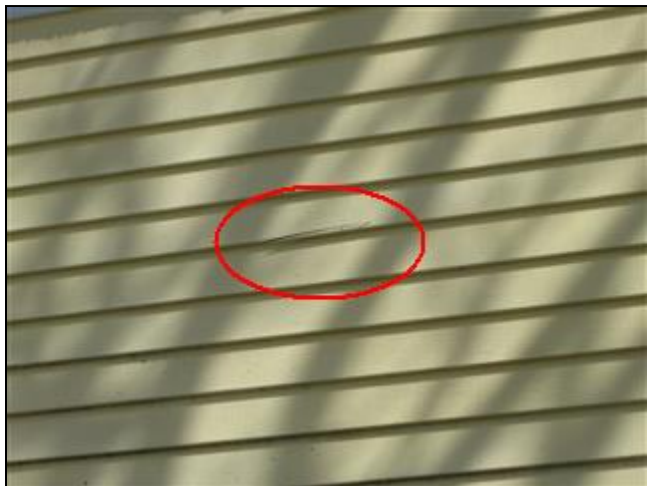
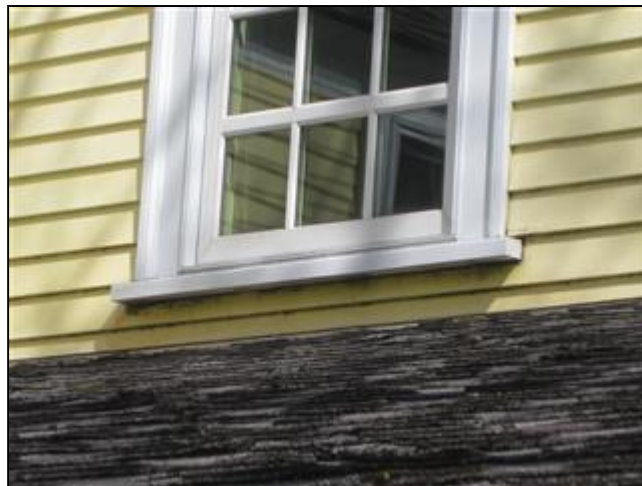
2.0 (1) WALL CLADDING: South facing upper floor a piece of the clapboard was cracked. Recommend a qualified person repair/replace this piece. The area around the low pitch roof show signs of dirt. Typical and I recommend having the siding cleaned to extend the life of the paint and siding material.

2.0 Picture 1 Cracked clapboard

2.0 Picture 2 Dirty cladding

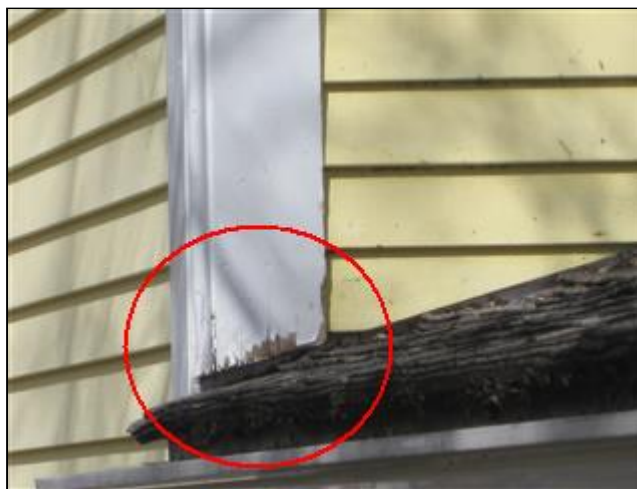
2.0 (2) TRIM: Sunroom roof area is showing signs of peeling paint on the corner board- this can lead to rot. recommend a qualified painter repaint and inspect the corner board.

2.0 Picture 3 Corner Board

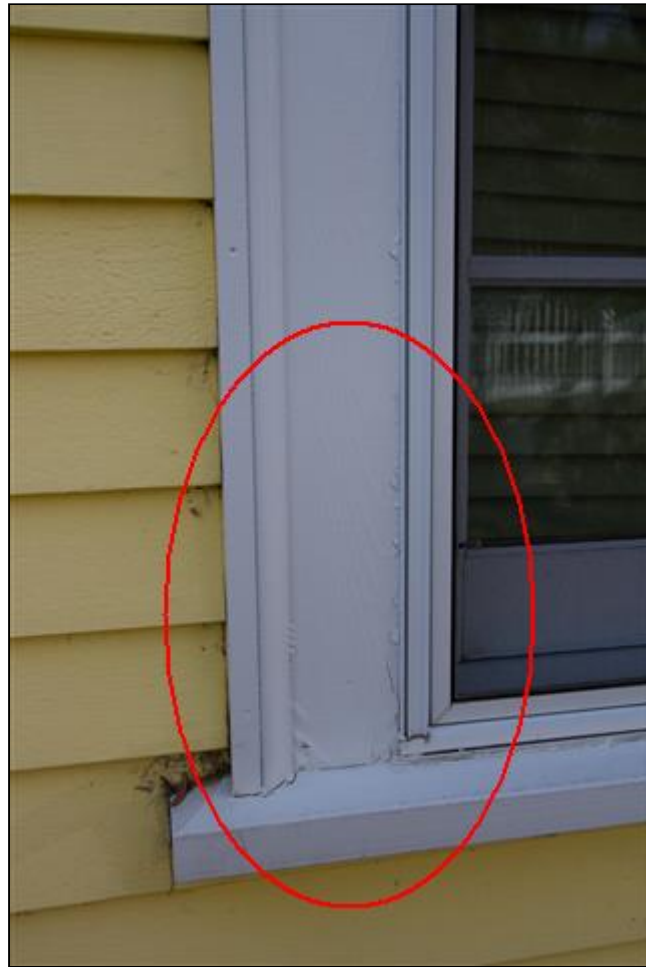
2.0 (3) WINDOW TRIM: Some of the window casing has blistering paint. This is a typical sign of water penetration- recommend a qualified painter re-seal and repaint these areas. If rot is present the trim piece should be replaced.

2.0 Picture 4 Window Trim

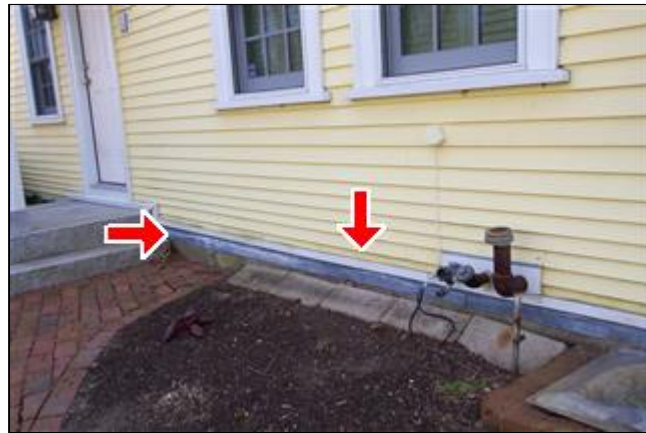
2.0 (4) RAIN BOARD: It appears that the rain (skirt) board has been replaced. The foundation cap flashing appears to be a flexible metal flashing and is in good shape.

2.0 Picture 5 Rain board - TYP

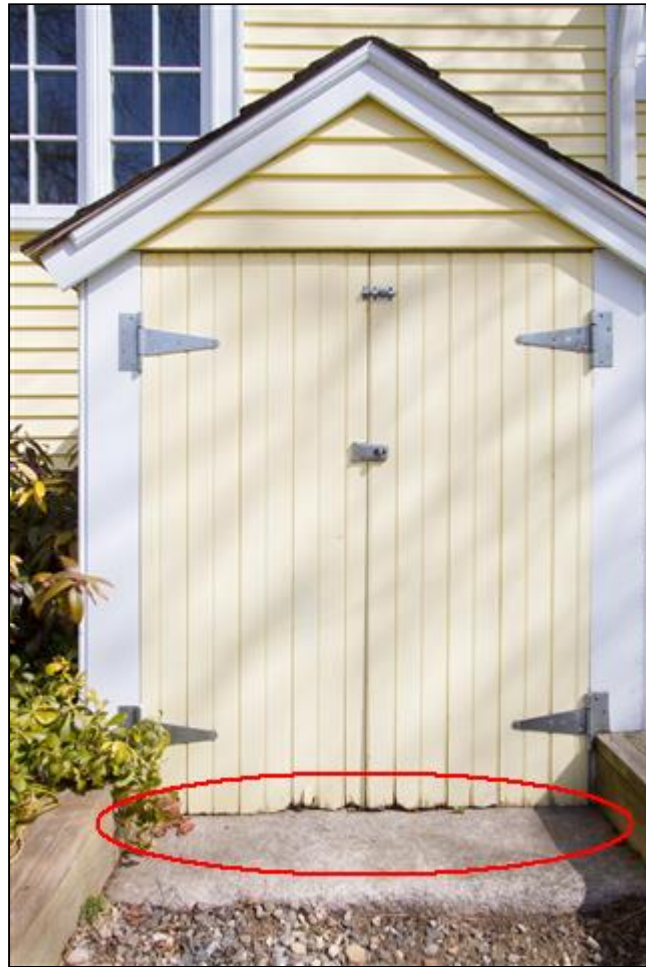
2.0 (5) CRAWLSPACE DOOR: The crawl space is accessed through this "dog house" door. The door is showing signs of water absorption & rot at the bottom. Monitor and repair as needed.

2.0 Picture 6 Basement Entrance

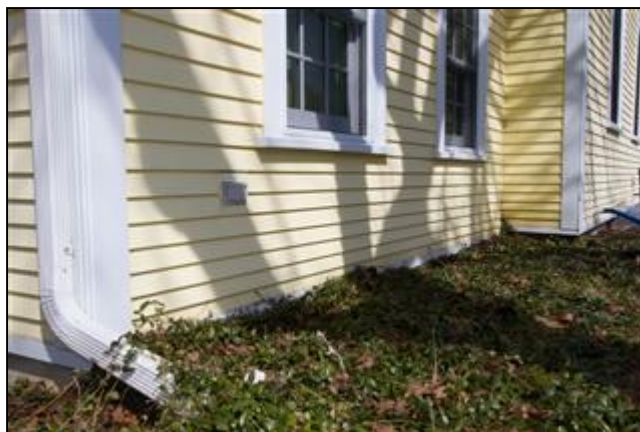
2.4 (1) VEGETATION: The vegetation (ground cover) near the sunroom should be trimmed back from the home. Vegetation can grow into foundations, crawl spaces and under slabs causing issues down the line.

2.4 Picture 1 Vegetation

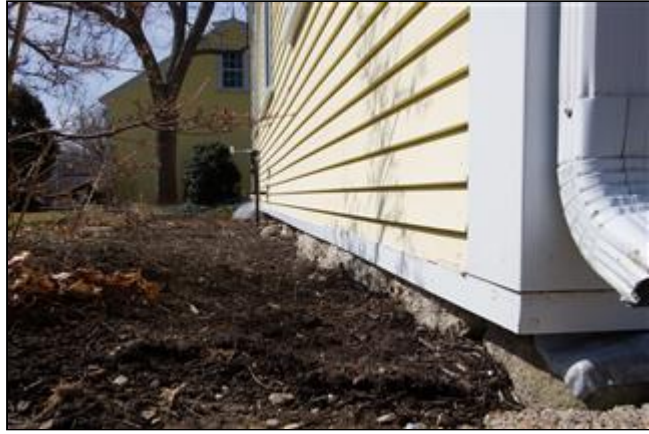
2.4 (2) GRADE: Typical for a home this age the level of grade is closer than the recommend 8" that we now look for.

2.4 Picture 2 GRADE

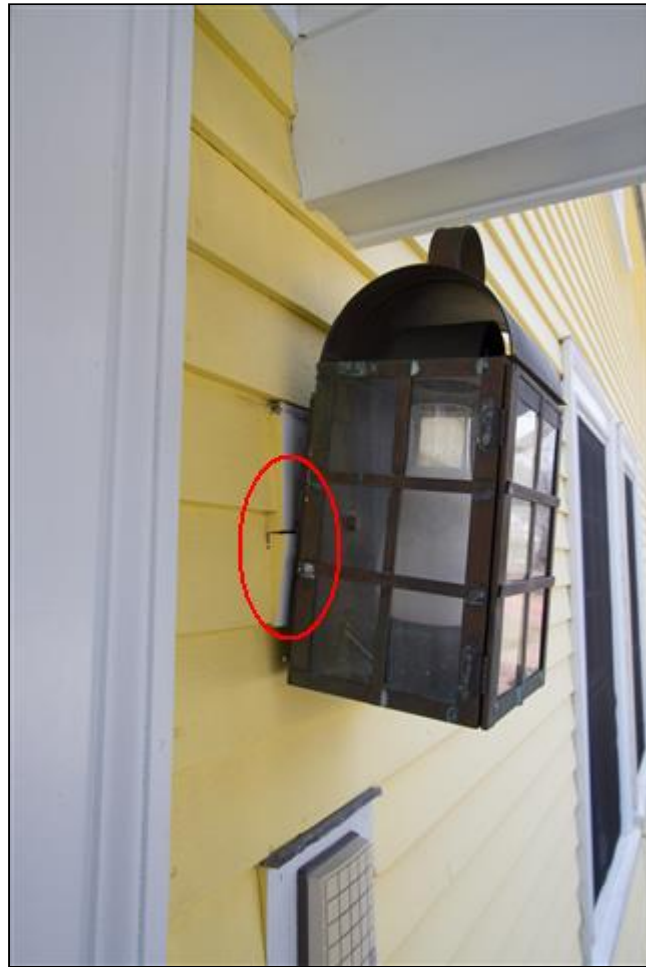
2.7 ELECTRICAL: The trim block behind the front entry light was pulling away from the home. Recommend a qualified person make the needed repairs.

2.7 Picture 1 Front Entry Light

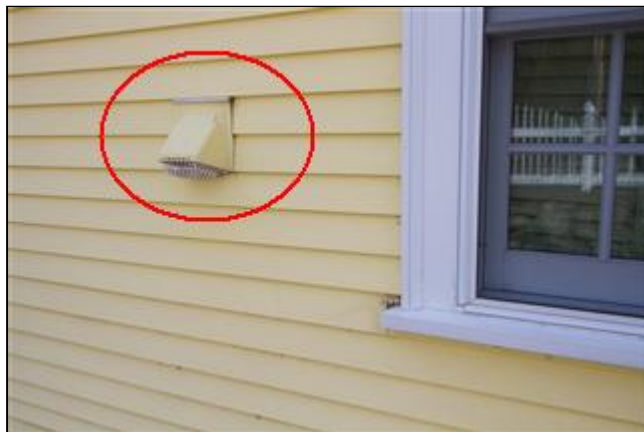
3.16 DRYER VENT: The pipe was inspected but the dryer was not operated. The screen on the exterior should be cleaned often and the interior dryer lint filter should be cleaned after every use.

3.16 Picture 1 Dryer Vent

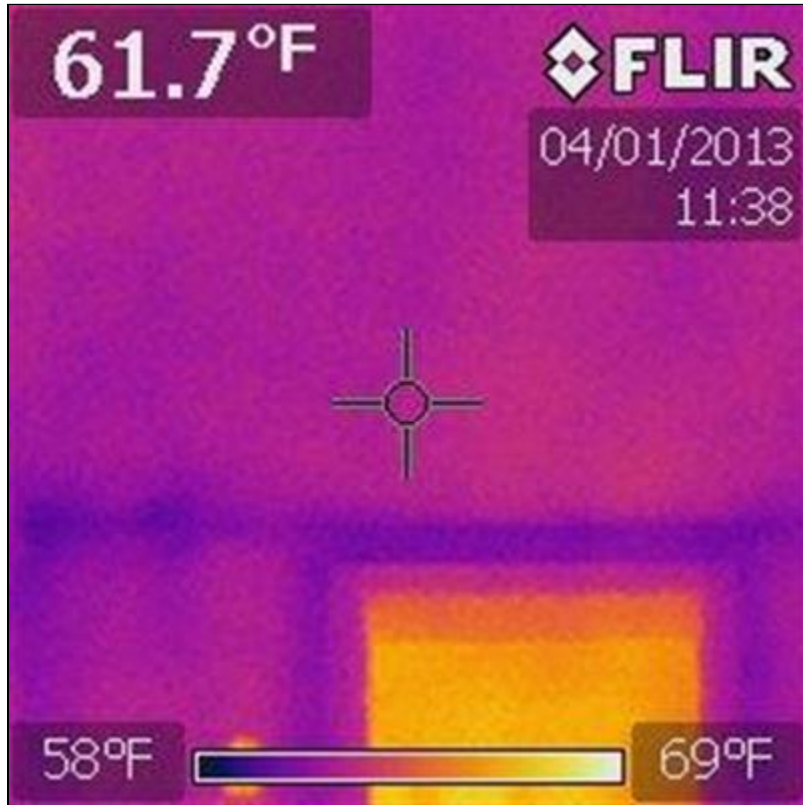
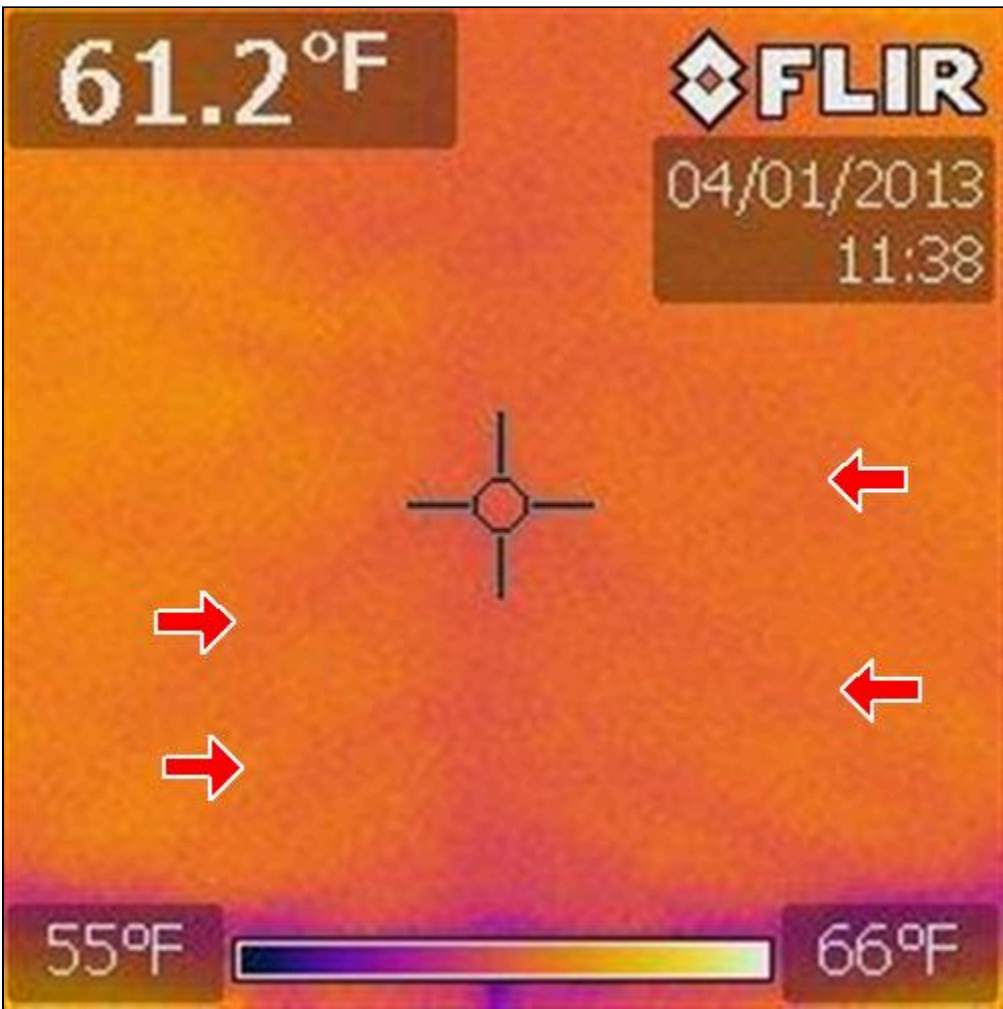
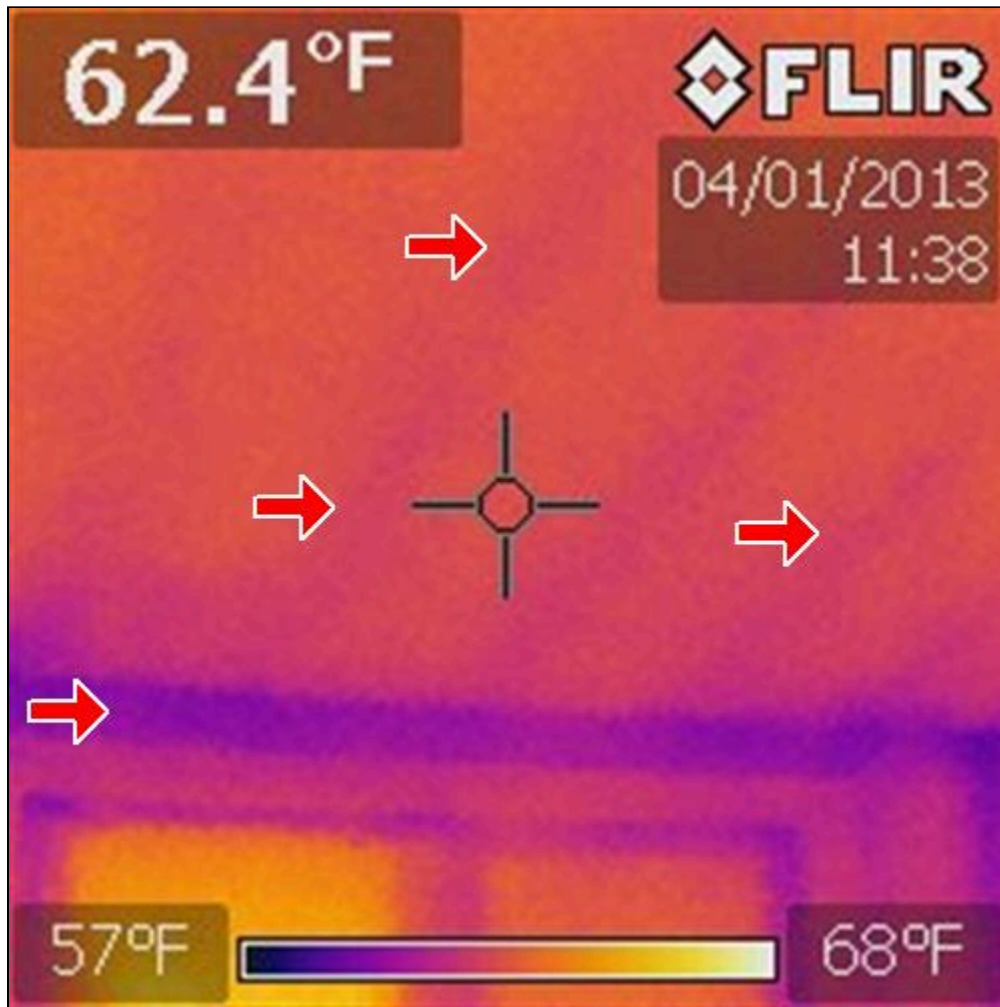
4.0.F CEILING: Minor crack on ceiling near joint. Thermal images showed no signs of water penetration. Monitor and repair as needed.

4.0.F Picture 1 Sunroom THERMAL

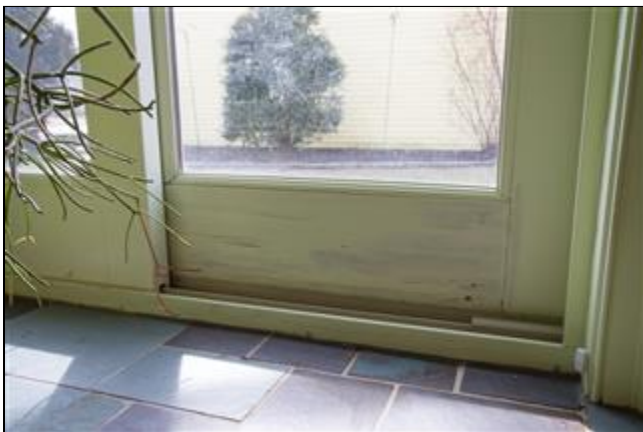
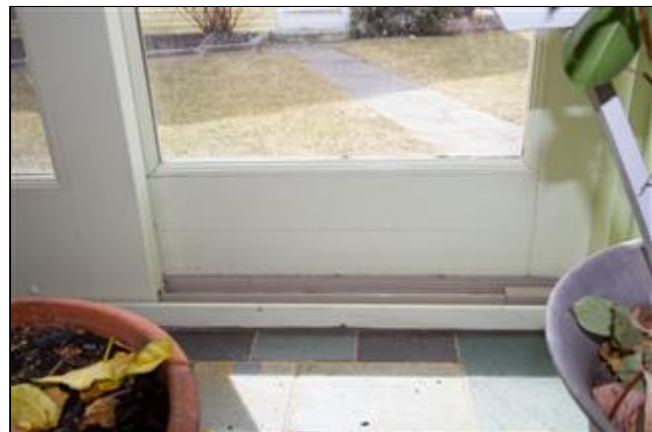
4.5.F SLIDERS: The fixed panel in the corner slider is showing signs of rot. Repair may be possible but replacement of entire sash is recommended. Recommend a qualified contractor perform the replacement. The middle set of sliders is showing early signs similar to corner slider. Monitor and repair/replace as needed.

4.5.F Picture 1 Slider rail rot

4.5.F Picture 2 Slider rail rot

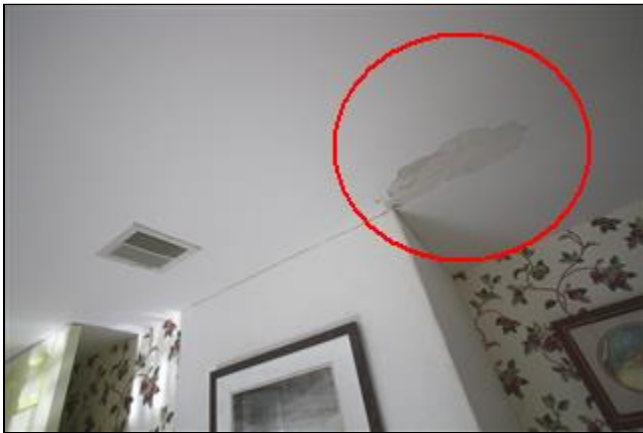
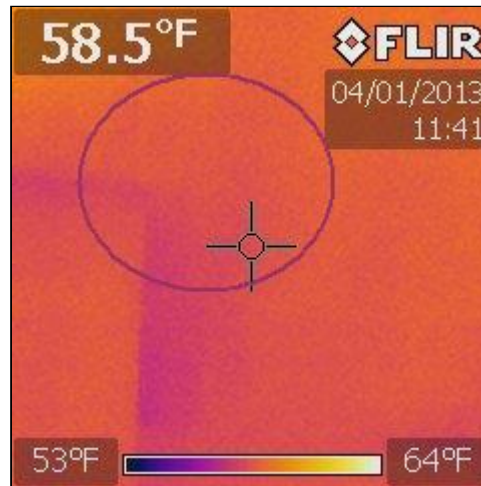
4.0.G UPSTAIRS BATHROOM: The ceiling plaster skim coat around the chimney has fallen as a result of chimney flashing leak. The leak does not appear active but the plaster should be repaired by a qualified professional. Home owner discloses that leak was fixed several years ago. Thermal images showed no signs of moisture.

4.0.G Picture 1 Upstairs Bathroom

4.0.G Picture 2 THERMAL of Ceiling

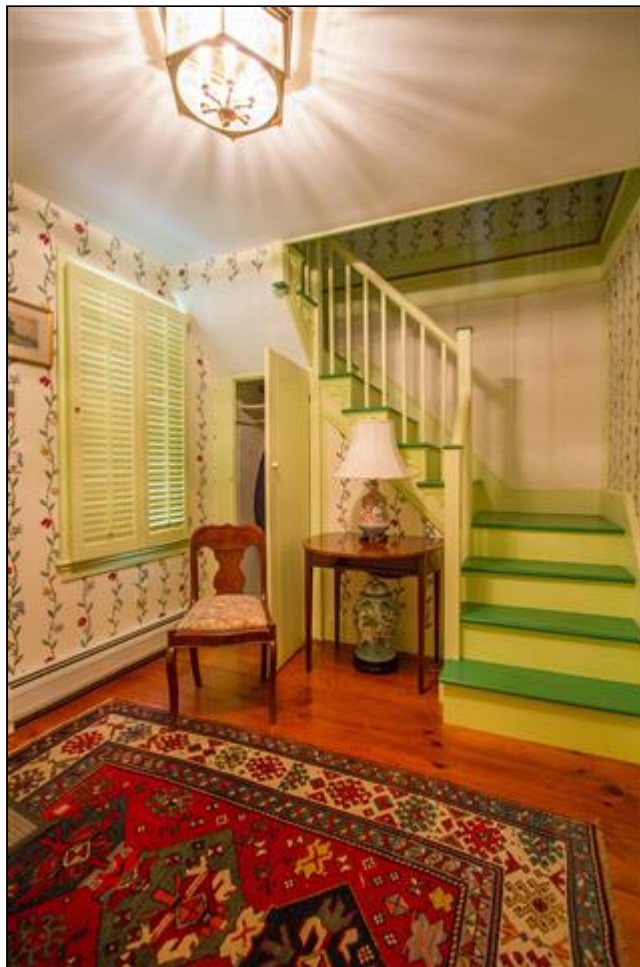
4.3.G STAIRS: The stairs appear original to the home or at least from a renovation many decades ago. They do not meet current codes but are firm and solid. They appear in better shape than some stairs that I have inspected recently that **DO** meet current code. No current repair is needed but you should monitor and repair if necessary.

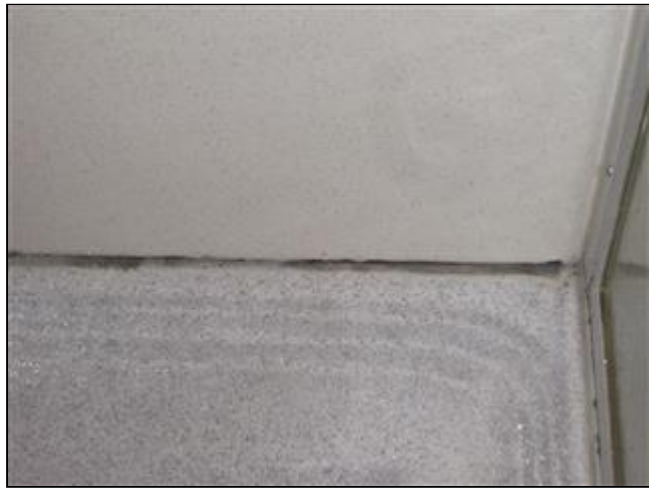
5.4.A SHOWER: The sealant around the shower panels are showing signs of mildew. Some cleaning may remove it but if it persists a qualified person should replace the sealant.

5.4.A Picture 1 Shower Sealant.

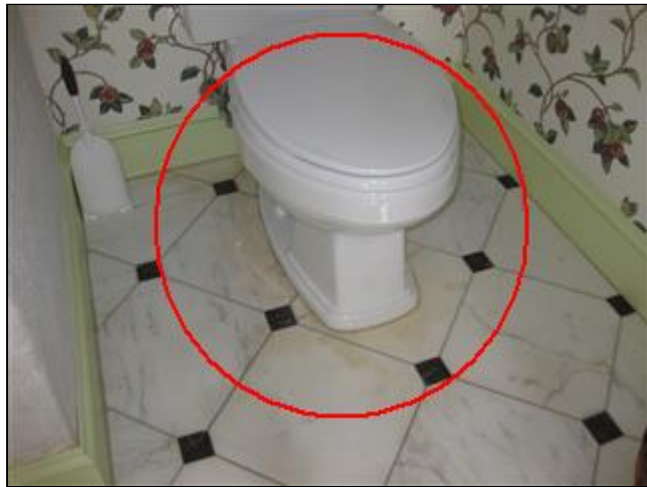
5.4.B TOILET RING: There was staining present around the base of the toilet. This could be the sign of a failed wax ring. Although there was no evidence below the bathroom the staining should be monitored to see if it progresses. Alternatively, a qualified plumber could be contacted to remove the toilet and have the ring replaced.

5.4.B Picture 1 Toilet Stains

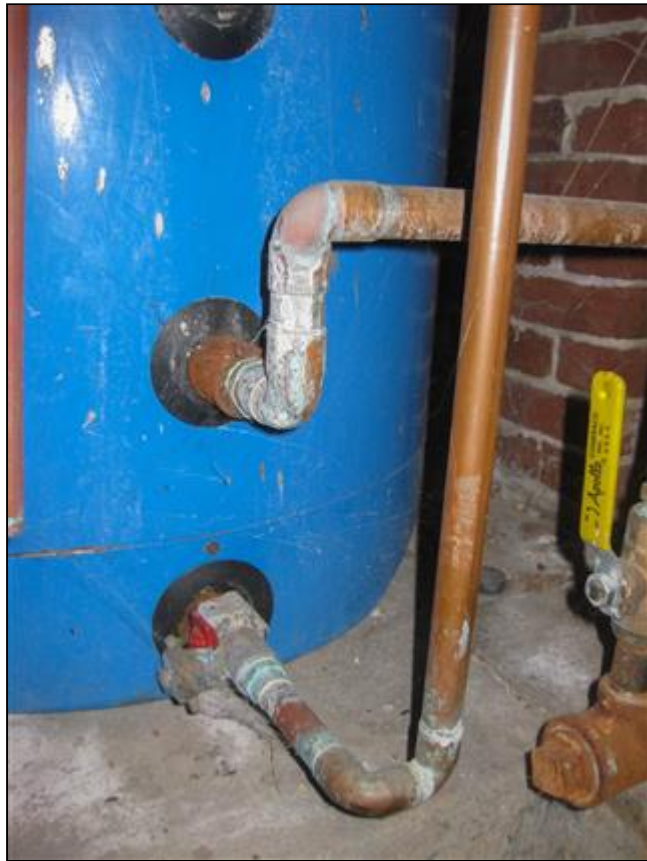
7.2 (2) WATER PIPES: There are early signs of topical corrosion on the copper pipes. Given the unconditioned space and the proximity to the ocean this corrosion isn't surprising but should be monitored and repaired as necessary during annual maintenance/service.

7.2 Picture 3 Corrosion

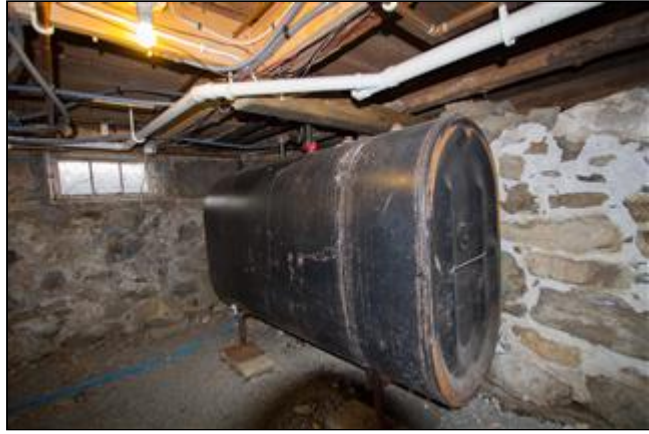
7.4 FUEL STORAGE: The tanks appears to have been replaced during the 2000 renovation. It is showing signs of exterior rust and corrosion typical for the unconditioned space and proximity to the ocean. The tank should be thoroughly inspected annually during the heat system maintenance.

7.4 Picture 1 Oil Tank

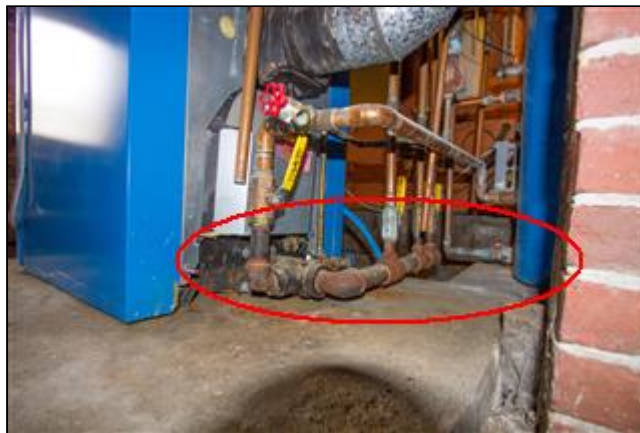
9.0 (2) PIPES: Some of the pipes connected to the boiler are showing signs of rust and corrosion. As detailed in the plumbing section this is most like a result of the unconditioned utility area and the proximity to the ocean. I recommend having the heating technician repair or paint as needed to stop the corrosion.

9.0 Picture 2 Rusting Pipes

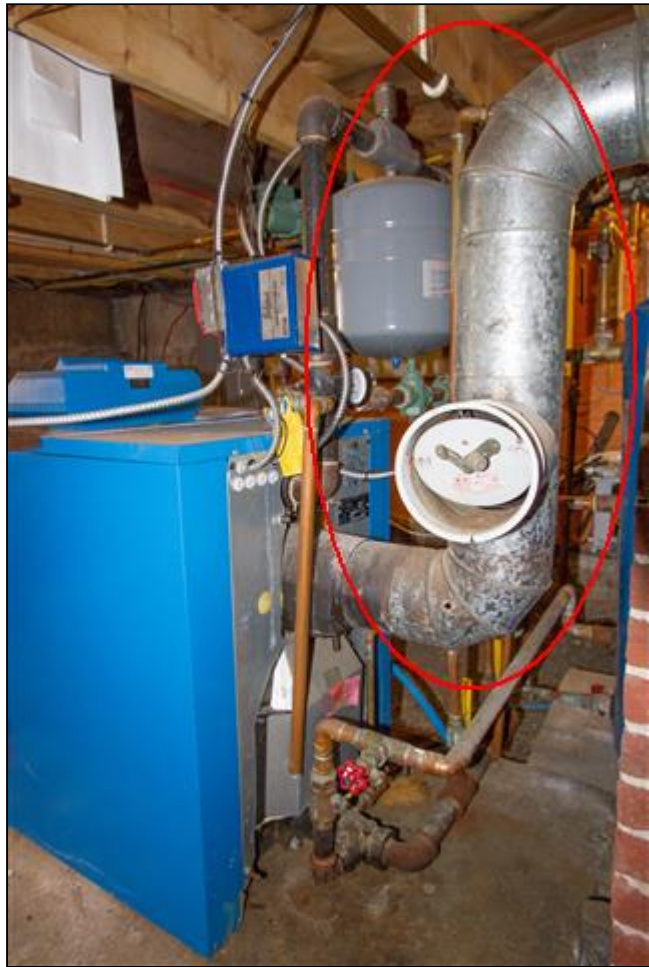
9.5 (1) BOILER FLUE: The flue pipe for the boiler is showing signs of environmental corrosion. As noted earlier: the unconditioned space and proximity to the ocean causes metal to corrode prematurely. Recommend a heating technician evaluate and replace as necessary.

9.5 Picture 1 Boiler Flue

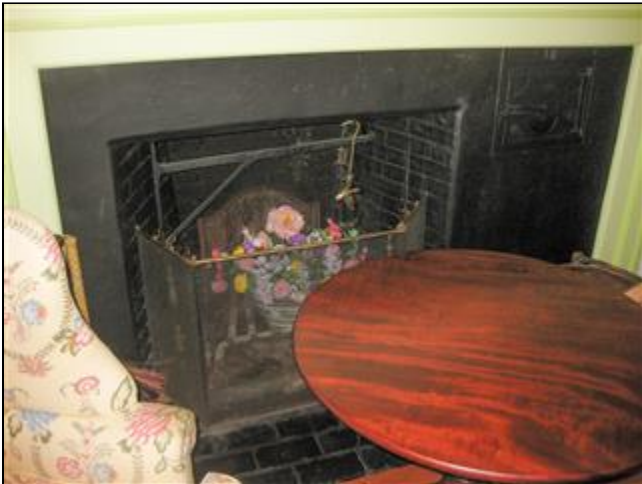
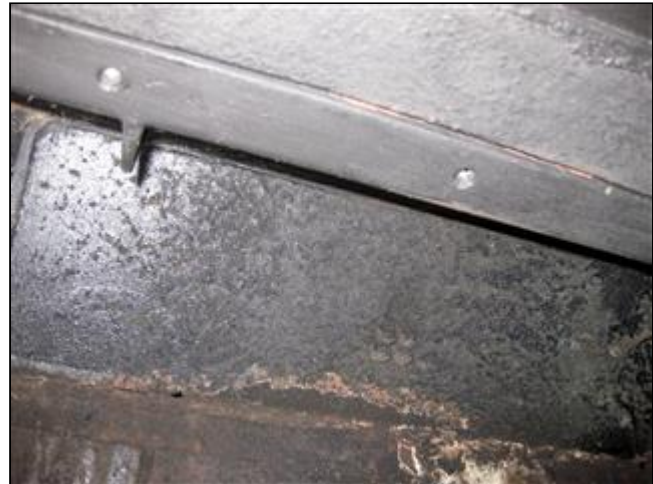
9.5 (2) LIVING ROOM FIREPLACE: The damper is showing signs of build up. Recommend a professional cleaning and evaluation by a trained and insured chimney sweep.

9.5 Picture 3 LR Damper

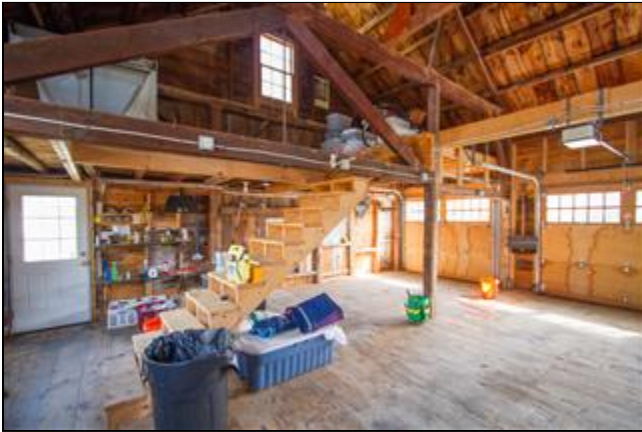
10.4 WALLS: The structure is post and beam so the structure is supported by the beams. The areas between beams are filled with wood framing and barn board. Signs of several repairs...it is over 100 years old so this is to be expected.

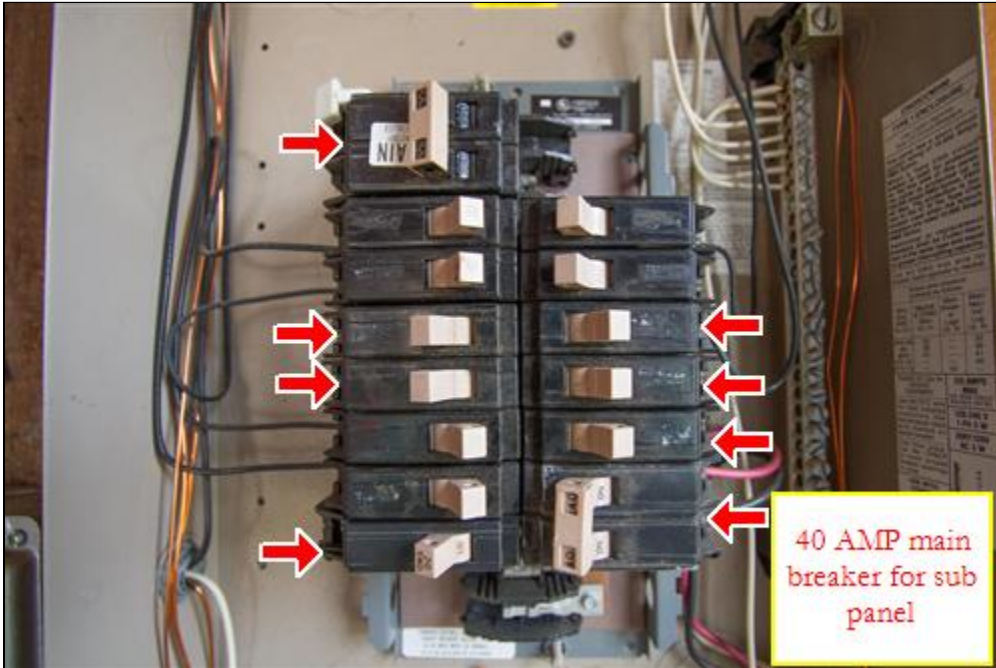
10.9 Picture 1 Unused Circuit Breakers
