Inspection Report

Property Address:
190 Fay Way
Rye Beach New Hampshire 03871

DBC Home Inspections

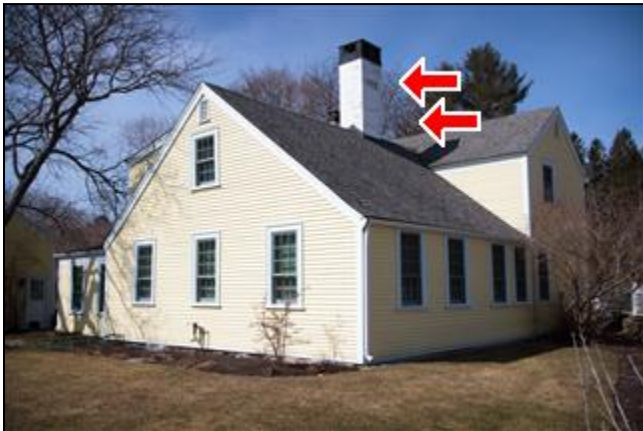
1.2 Picture 1 Chimney

1.2 (1) 1729 CHIMNEY: The paint on the chimney is showing signs of age and could benefit from being repainted. The sealing of the brick will help protect the brick that is standing up to the elements very well. Owner discloses that all the chimneys were lined during the 200 renovation.

1.2 (2) CHIMNEY: I recommend to all clients that they have the chimneys swept and inspected by a qualified Chimney Sweep upon closing on their home and that they repeat this process annually.

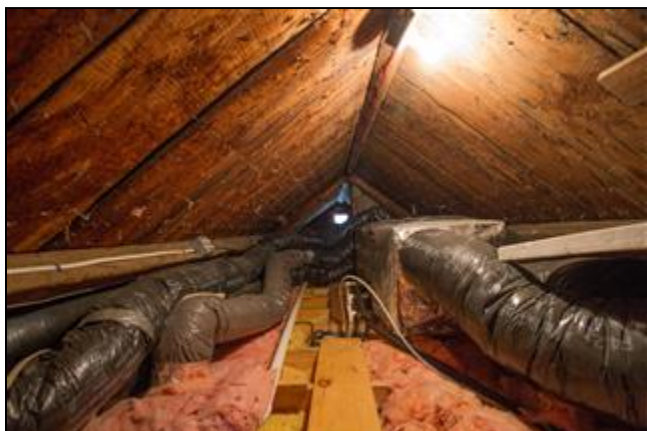
1.5 Picture 1 Roof Structure

1.5 STRUCTURE: The post and beam construction of the roof structure is typical for a home of this age. There were no signs of sagging or added stress to the structure. Monitor and consult a qualified professional if signs of stress appear in the future.

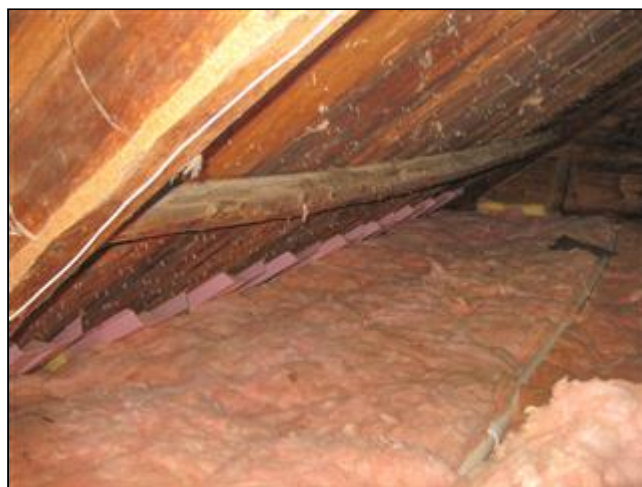
1.7 Picture 2 Attic Insulation

1.7 INSULATION: The insulation is adequate but there is always room for improvement. No visible vapor barrier was observed. A consistent vapor barrier is key for fiberglass insulation to reach its full efficiency.

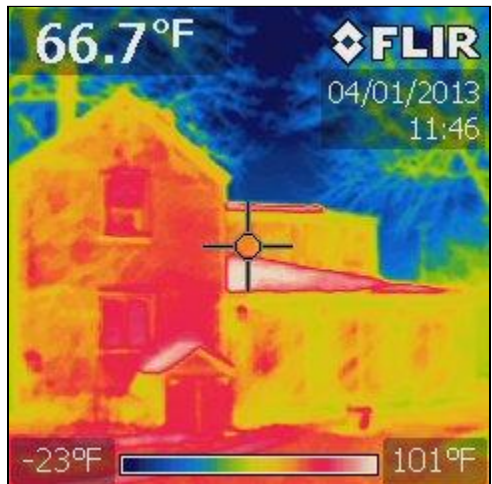
2.0 (6) THERMALS: It appears that the renovation in 2000 resulted in a very tight & well air sealed home.

2.0 Picture 7 South Face: in the sun at the time

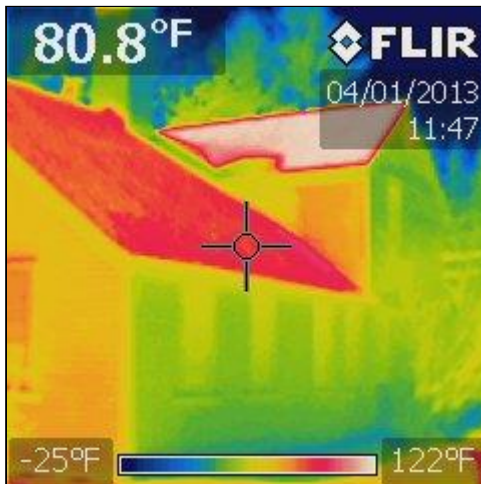
2.0 Picture 8 North face: no signs of heat loss from windows

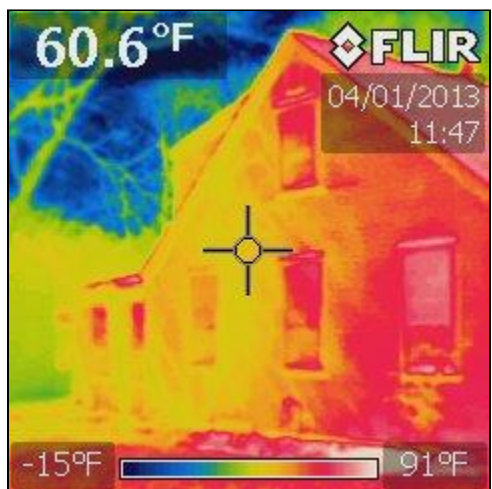
2.0 Picture 9 East Face: also in the sun.

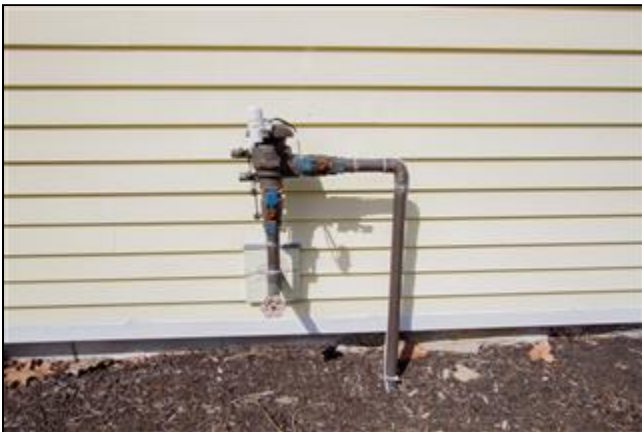
2.6 HOSE BIBS: Two bibs on the home: one on the east side and one on the west side (by oil fill).

2.6 Picture 1 EAST Hose Bib

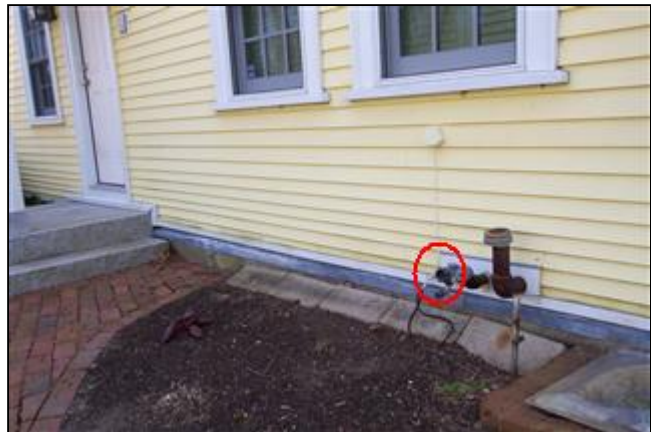
2.6 Picture 2 WEST Hose Bib

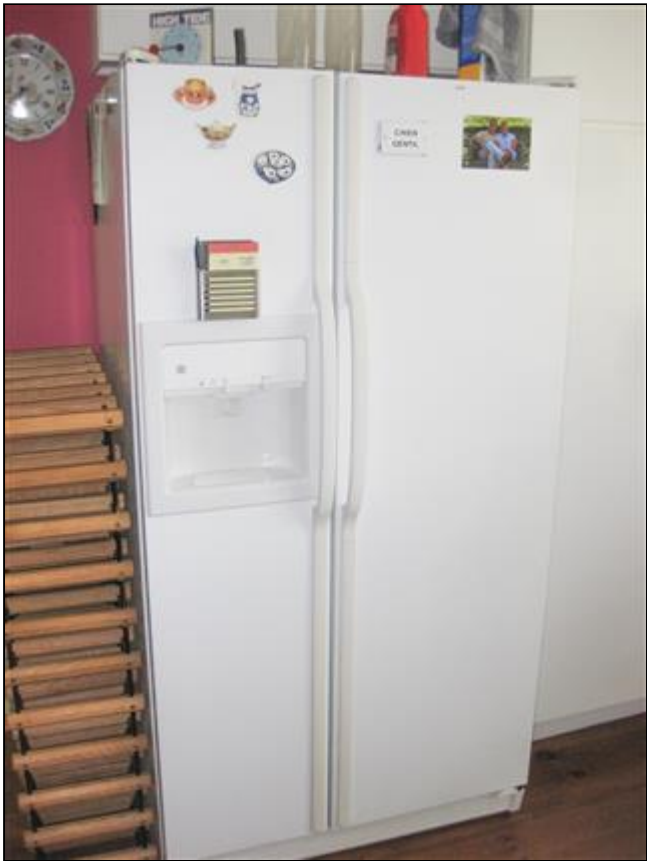
3.9 Picture 1 Refridgerator

3.9 REFRIDGERATOR: Present & Operable

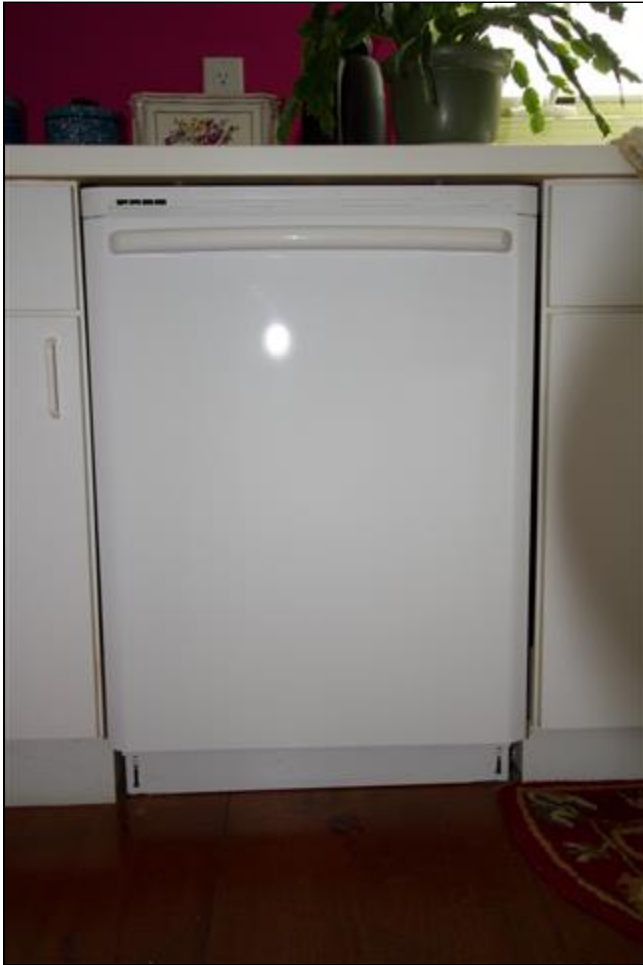
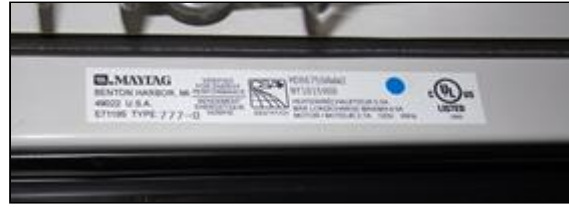
3.10 DISHWASHER: Present & Operable

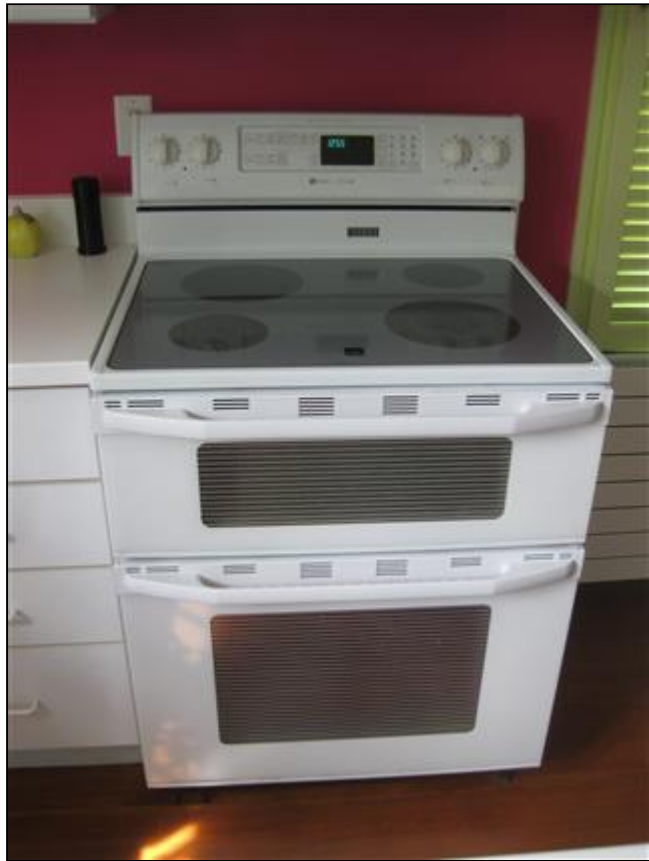
3.11 Picture 1 Oven

3.11 RANGE/OVEN: Present & Operable

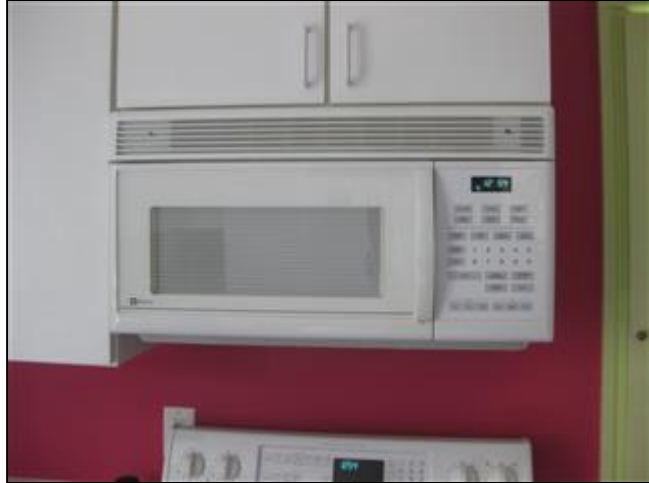
3.12 Picture 1 Micro Hood

3.12 HOOD: Present & Operable

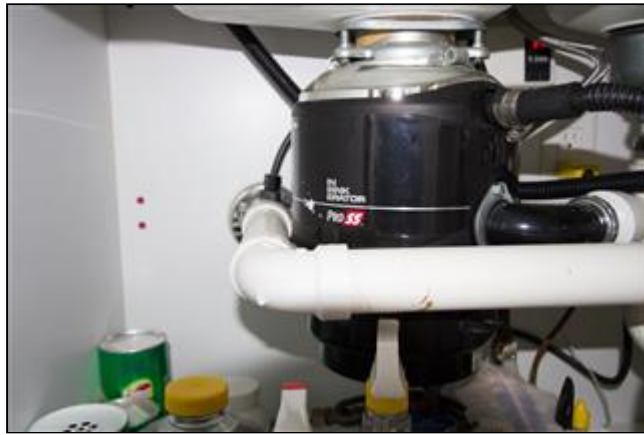
3.14 Picture 1 Garbage Disposal

3.14 DISPOSAL: Present & Operable

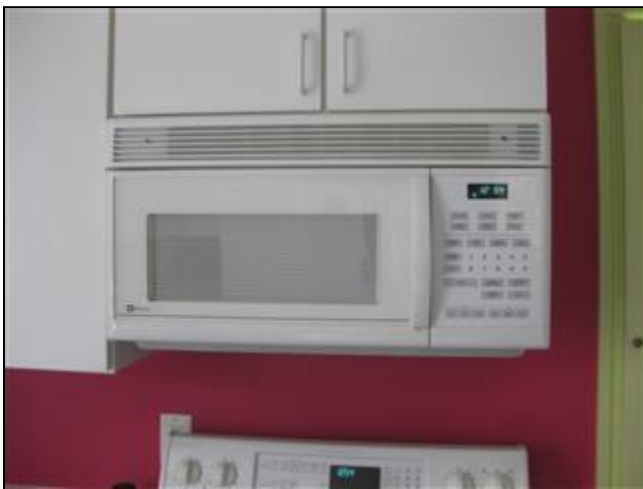
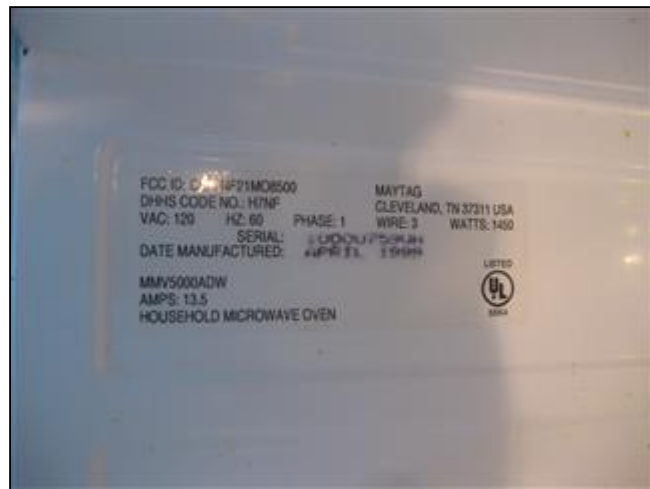
3.15 MICROWAVE: Present & Operable

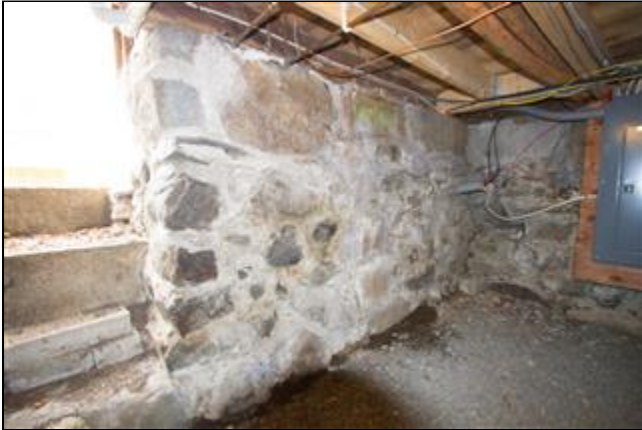
6.0 Picture 1 Stone Foundation

6.0 CRAWLSPACE: The crawl space is an easily access area under 70% of the home. In these areas there is ample amount of clearance for work to be performed. All the utilities are located in this area. The foundation walls are a mix of all the foundations types. All of these types were properly enforced, repaired or added during a renovation in 2000. The ground cover is many inches of crushed stone that has been packed. It has been disclosed that during high volumes of rain this area can flood but there is no evidence high water marks above a couple of inches. All the utilities have been lifted off the ground sufficiently. There are three sump pumps installed and operating.

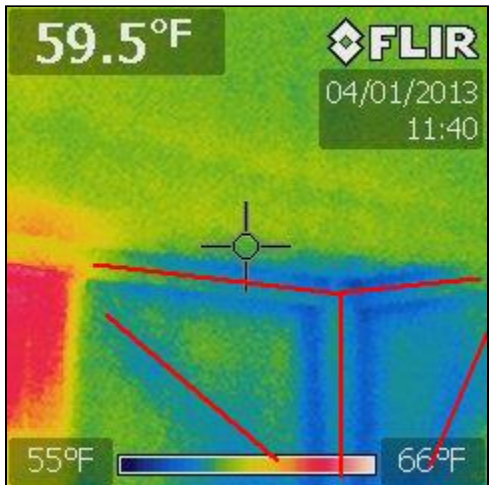
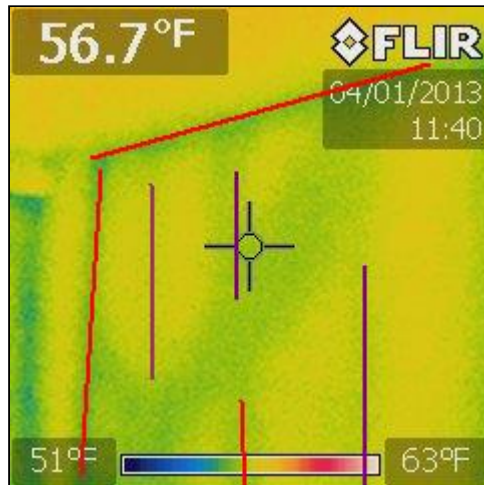
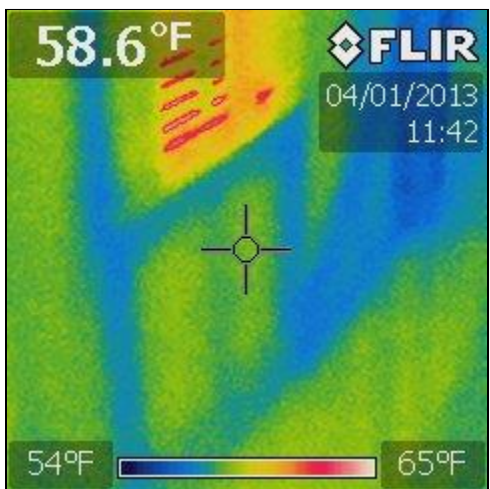
6.1 WALLS: These selected thermal images show the framing that is typical for this home. It appears that the renovation involved marrying old original post and beam construction with modern dimensional framing. There were no signs of leaks or insulation voids. It appeared to be a very sound and tight house.

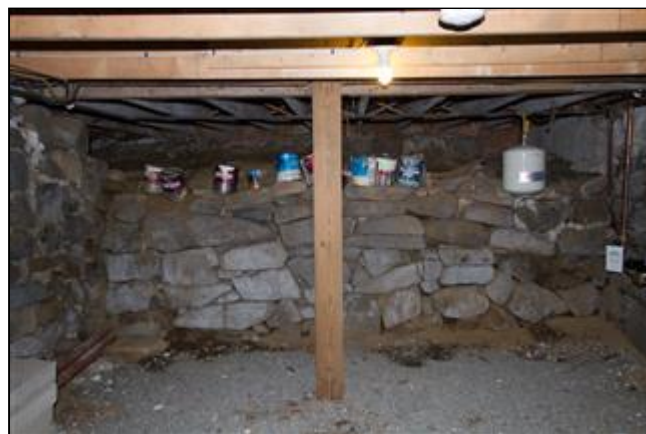
6.2 Picture 1 Wood Pier

6.2 PIERS: Present and in good shape. Monitor for movement.

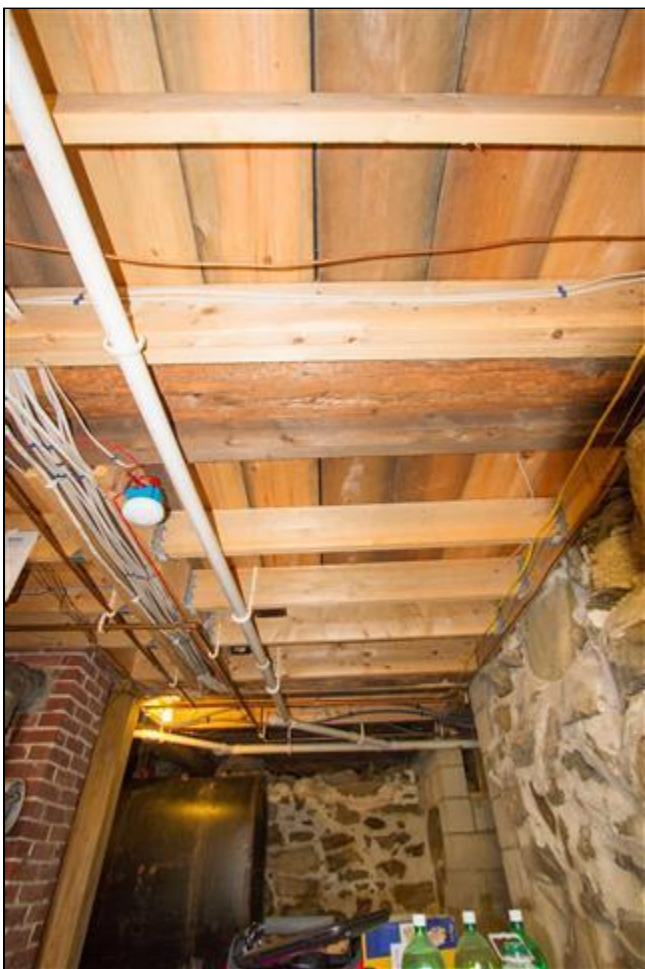
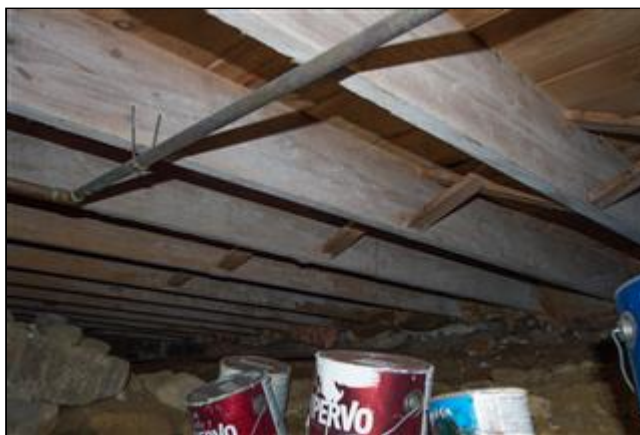
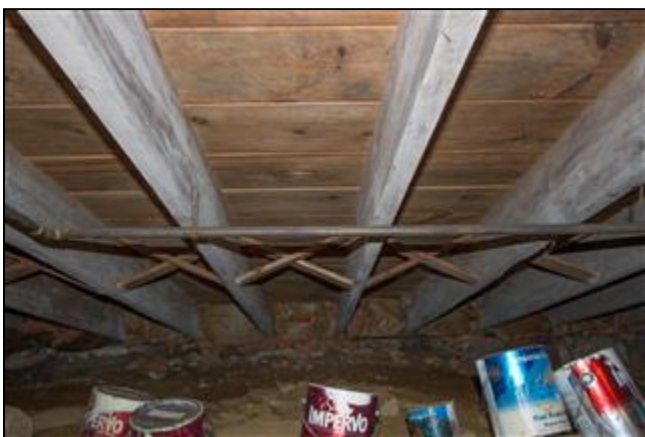
6.3 FLOORS: Signs of several additions & sistering from the 2000 renovation and prior events.

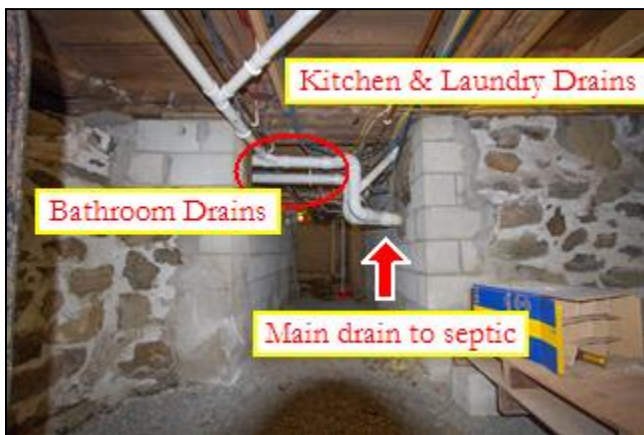
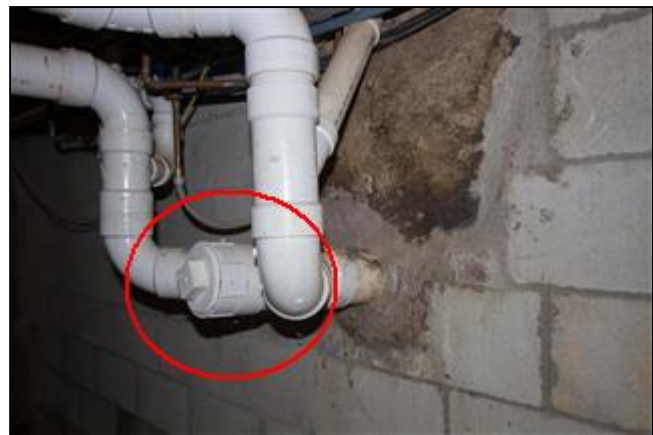
7.0 PLUMBING DRAINS: The plumbing appears to have been completely updated during the 2000 renovation.

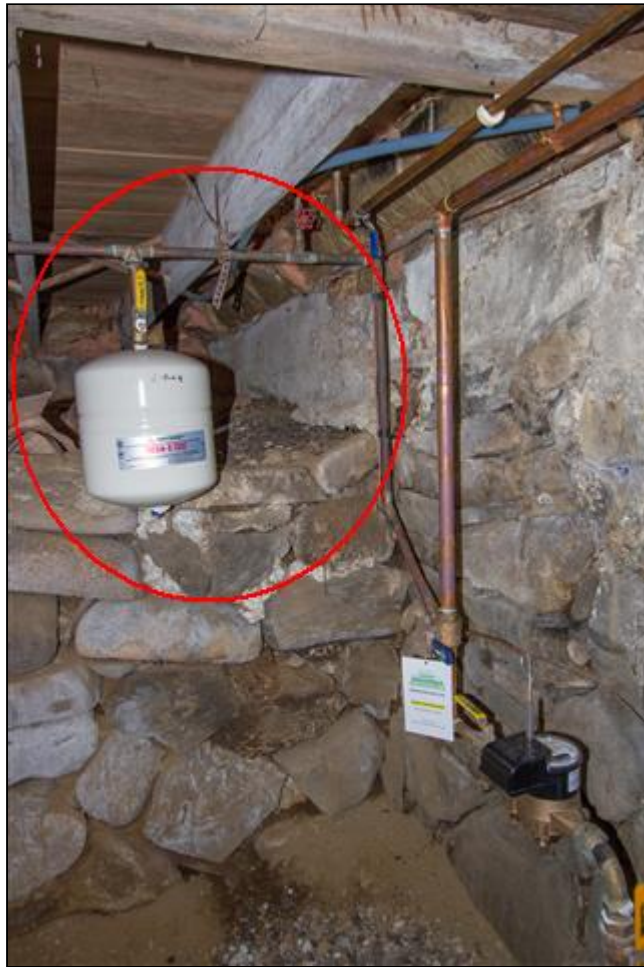
7.1 Picture 1 Expansion Tank

7.1 (2) EXPANSION TANK: There is an expansion tank installed on the water supply system. This tank should be inspected for leaks and corrosion annually or as needed.

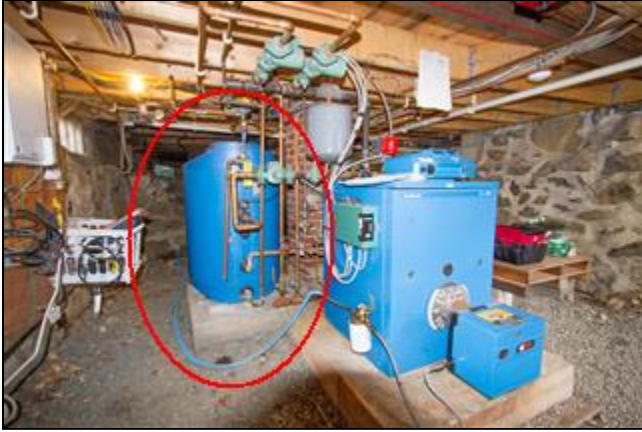
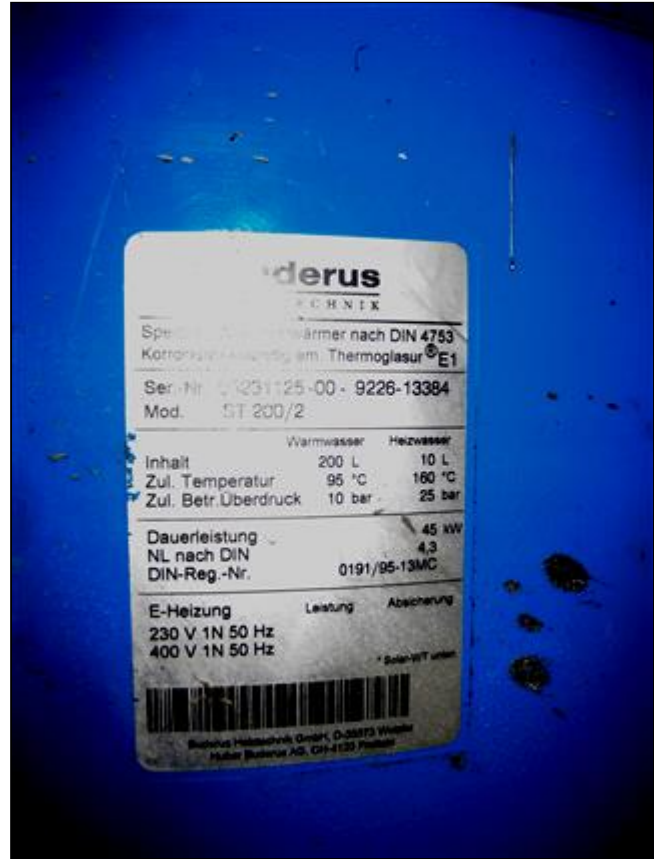
7.2 (1) HOT WATER: The domestic hot water is heated by the boiler and stored in the pictured tank. The control of the hot water is through the boiler's computer. Manuals present.

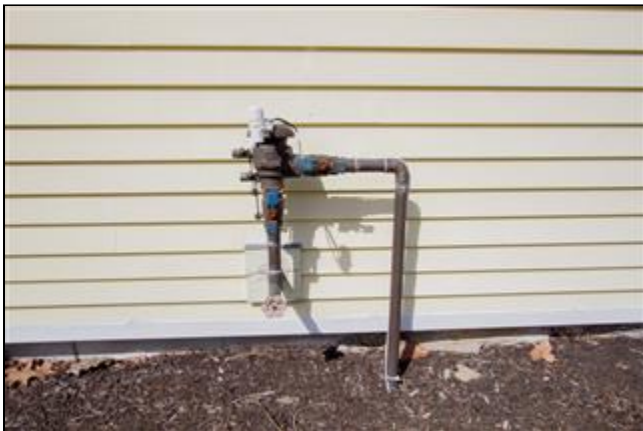
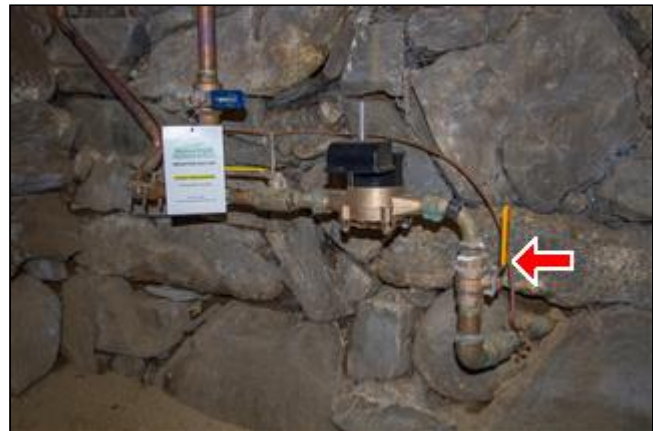
7.3 WATER SHUT OFFS: There are two main shut offs. A ball valve on the interior of the crawlspace on the east wall and on the exterior of the east wall.

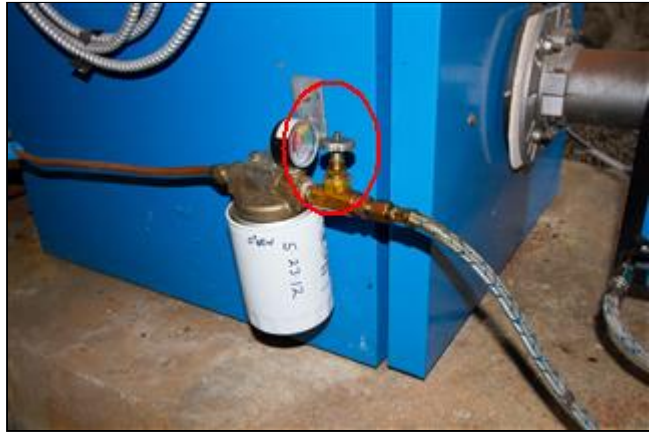
7.5 Picture 1 Fuel Shut Off

7.5 FUEL SHUT OFF: The main fuel shut off is located by the boiler next to the oil filter.

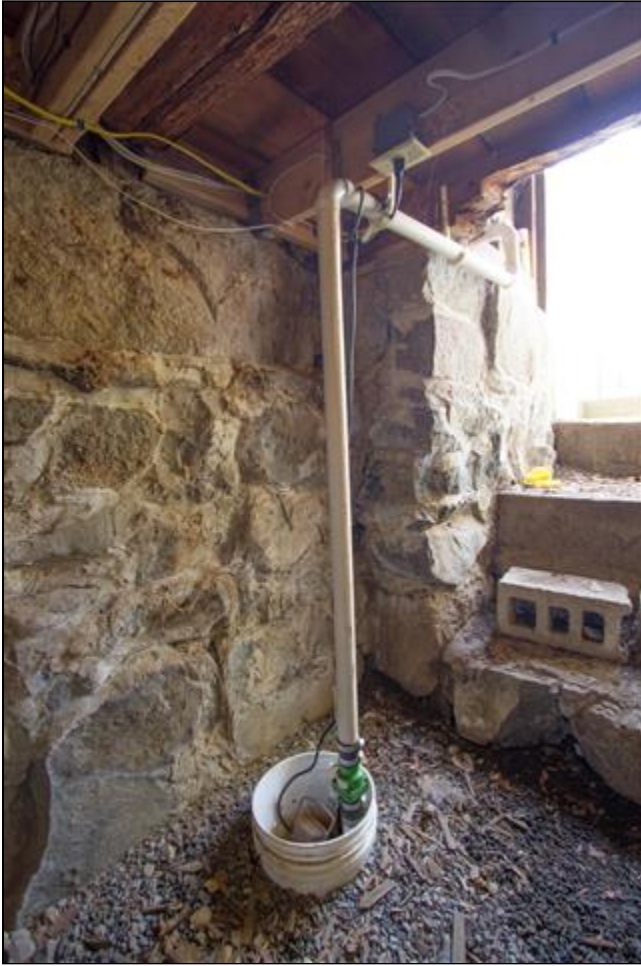
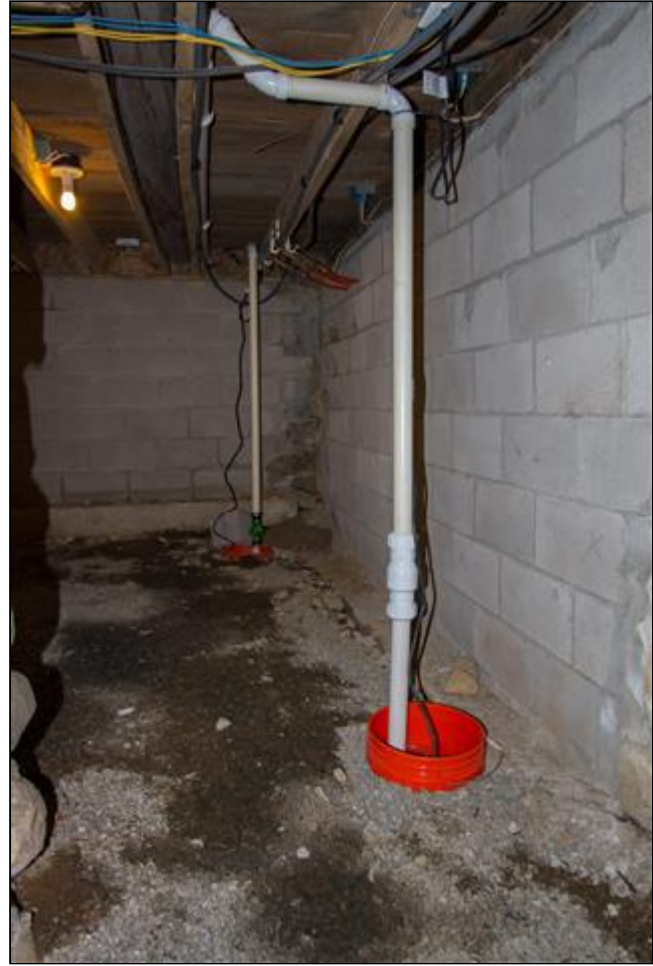
7.6 SUMP PUMPS: There are three sump pumps located in the crawlspace: one by the entrance to the south and then two over in the east section of the crawlspace. All three pumps are placed in submerged 5 gallon buckets that have been perforated to allow ground water to enter. The system appears to work well but a good improvement would be to add a battery back up to the system.

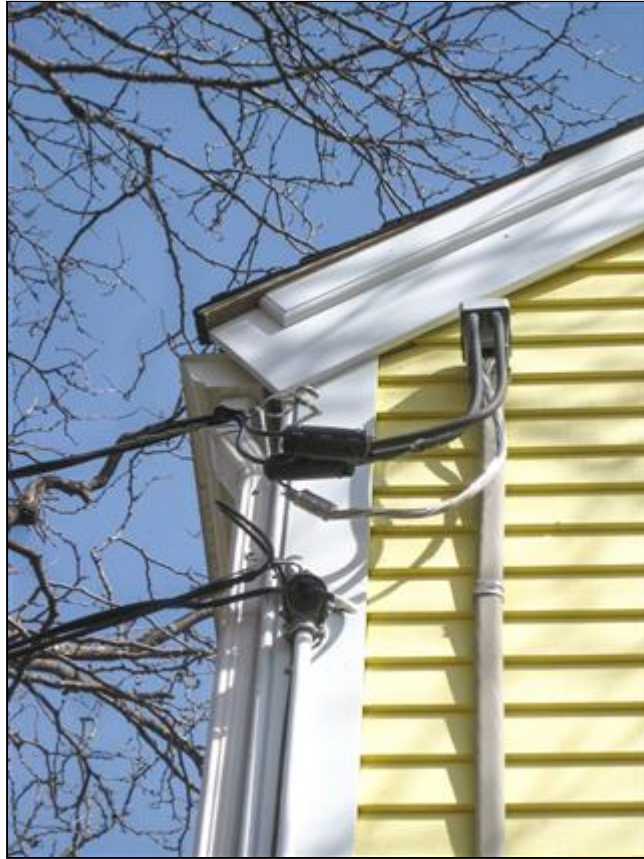
8.0 Picture 1 Service Entrance Conductors

Overhead service comes in on the South West corner. These wires should be maintained and kept clear by your local electric supplier.

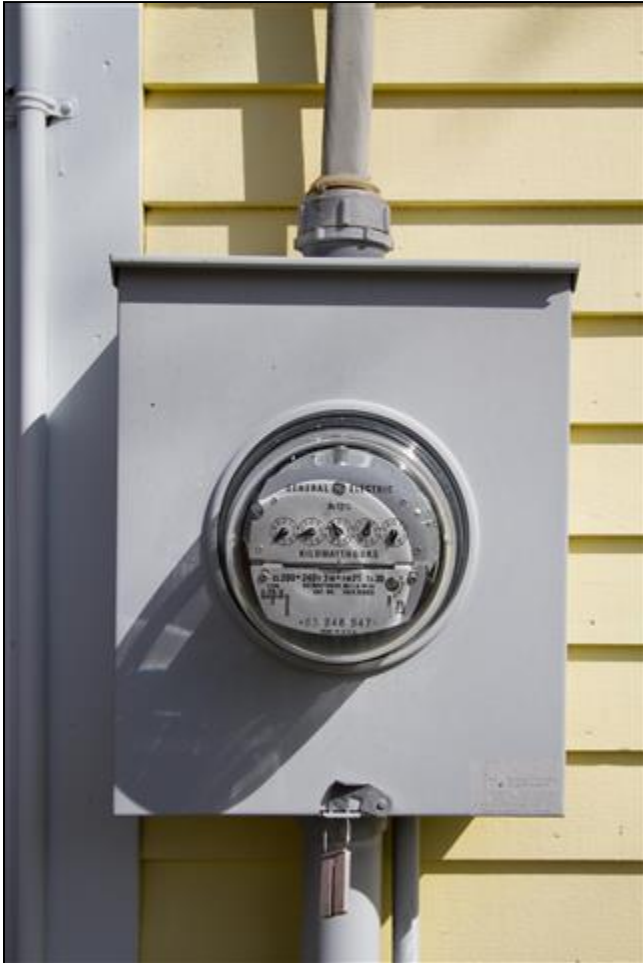
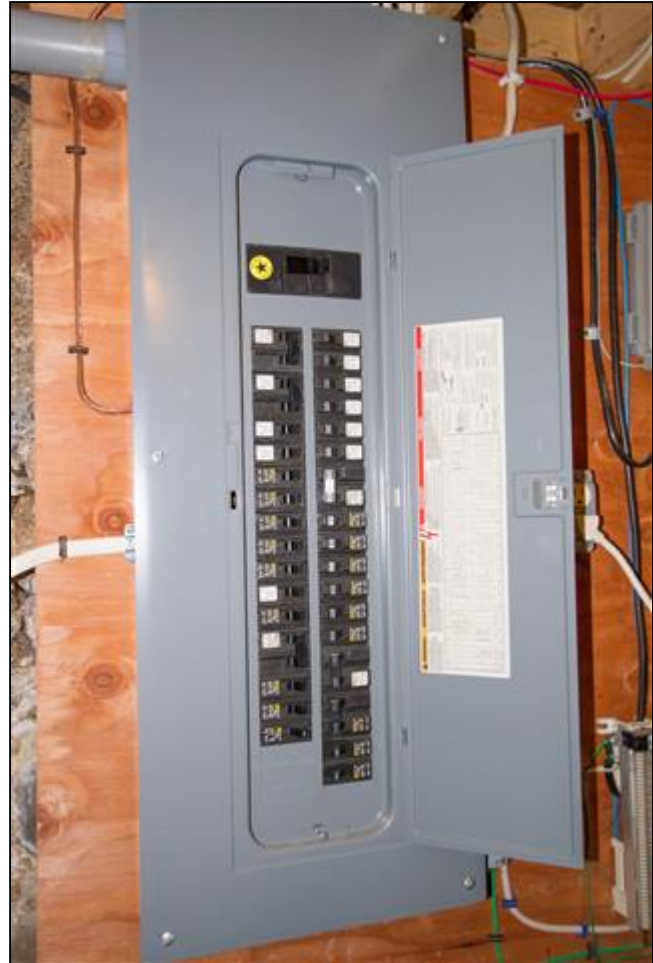
8.1 ELECTRICS: The meter and panel appear to have been installed as part of the 2000 renovation. There appears to be a sub panel in the Barn. The main panel box is located in the crawlspace. All the circuits are clearly labeled.

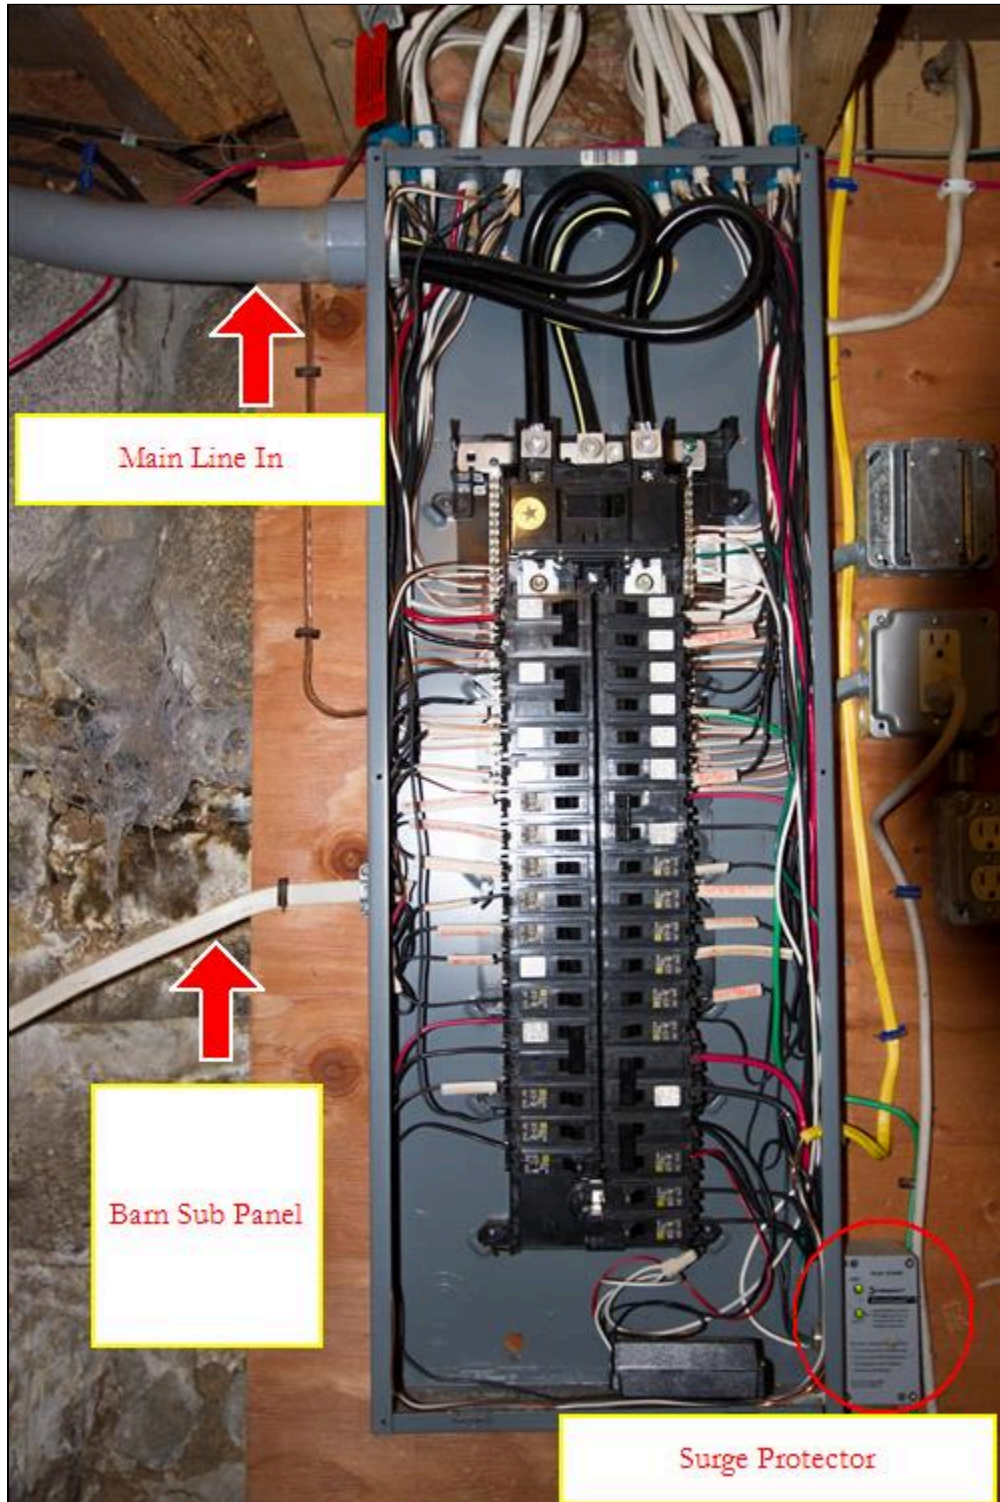
8.2 Picture 1

8.2 PANEL: The panel was updated in 2000 and appears in great working order. 200AMP service in the home with a sub-panel in the barn of 40AMPS. See Barn section for details.

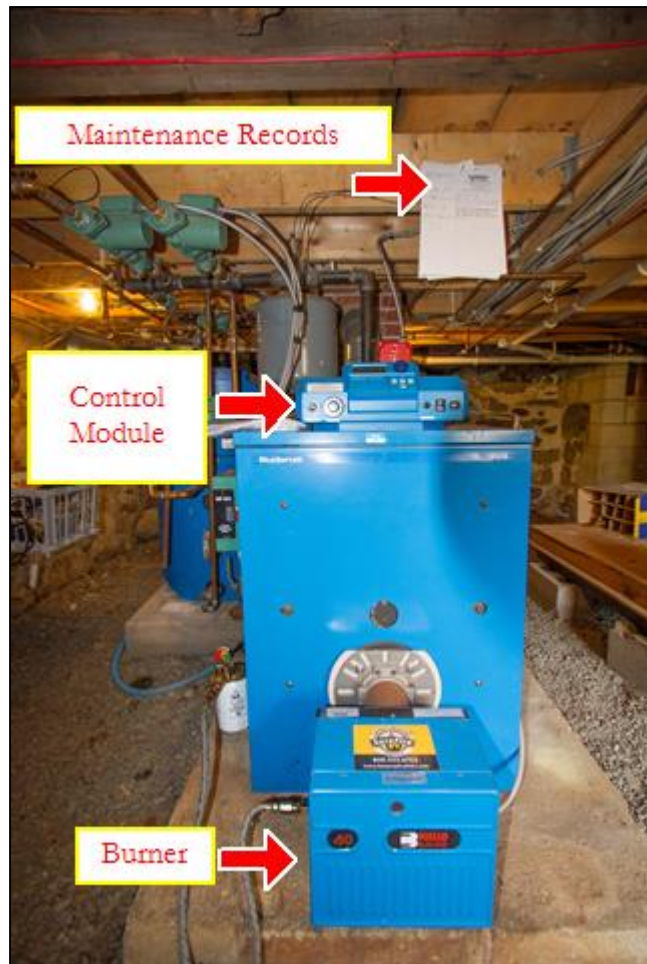
9.0 Picture 1 Boiler

9.0 (1) BOILER: This model boiler was top of the line at the time of installation. A current service record was present.

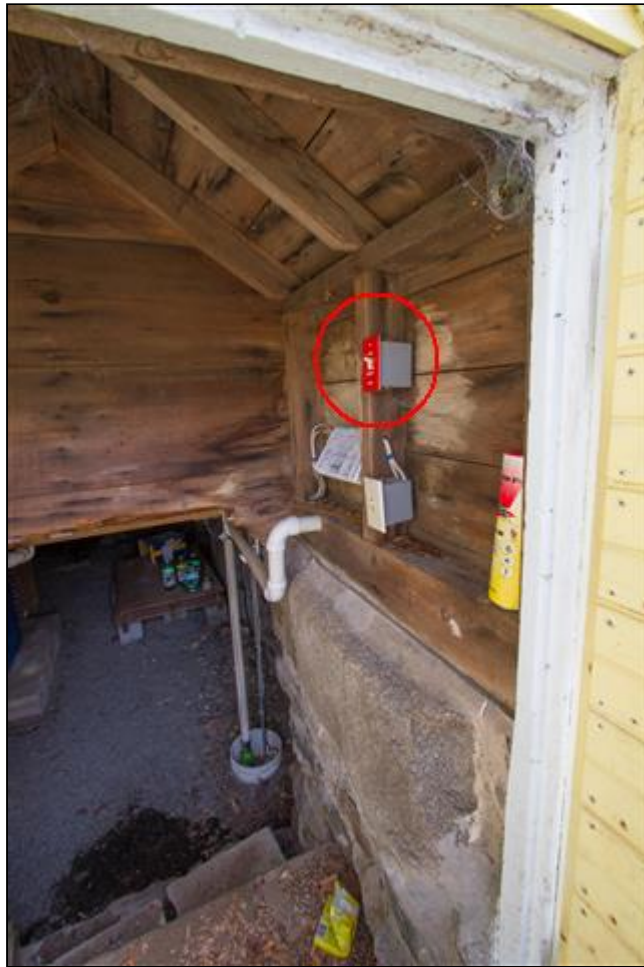
9.2 Picture 1 Boiler Safety Switch

9.2 HEATING SHUT OFF: The safety switch for the boiler is located right inside the crawlspace door.

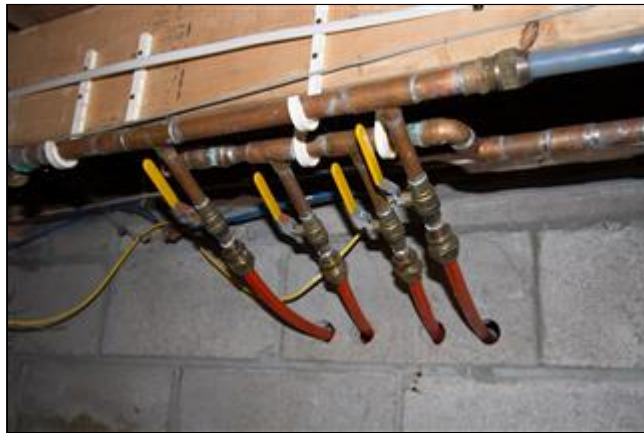
9.3 Picture 1 Radiant Heat valves

9.3 HEAT: The house is heated mostly with circulated hot water through baseboard, there are a couple modern radiators and the sunroom is heated with radiant floor heat.

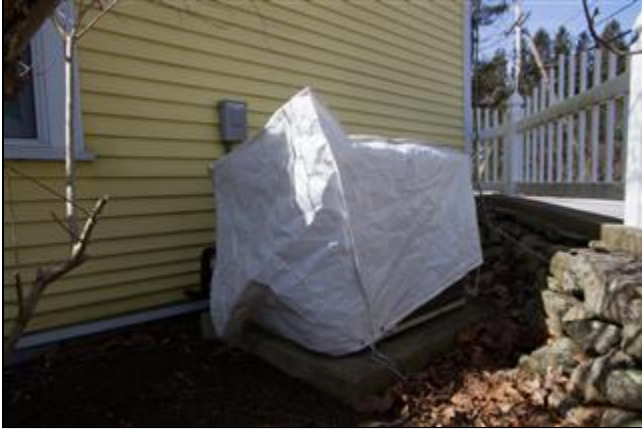
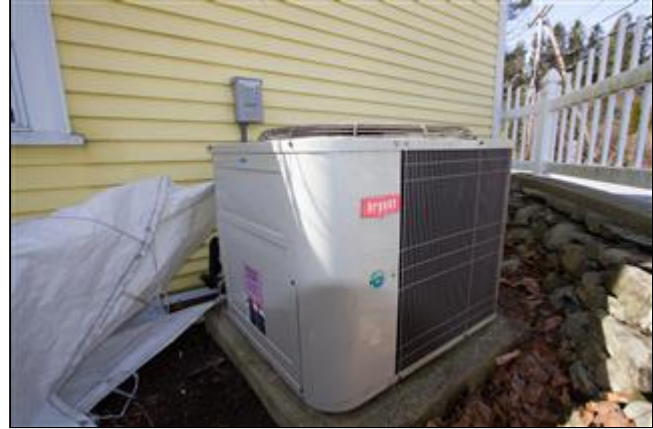
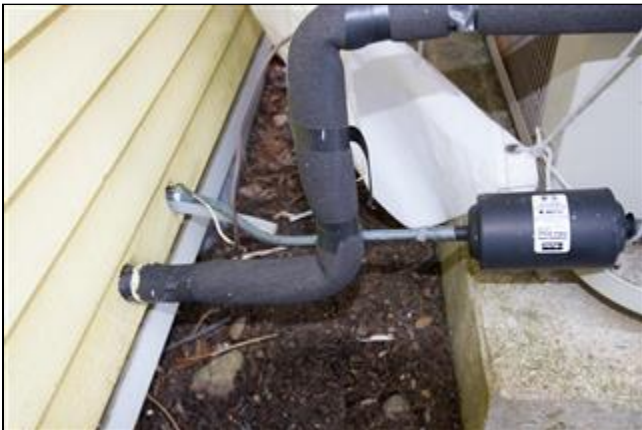
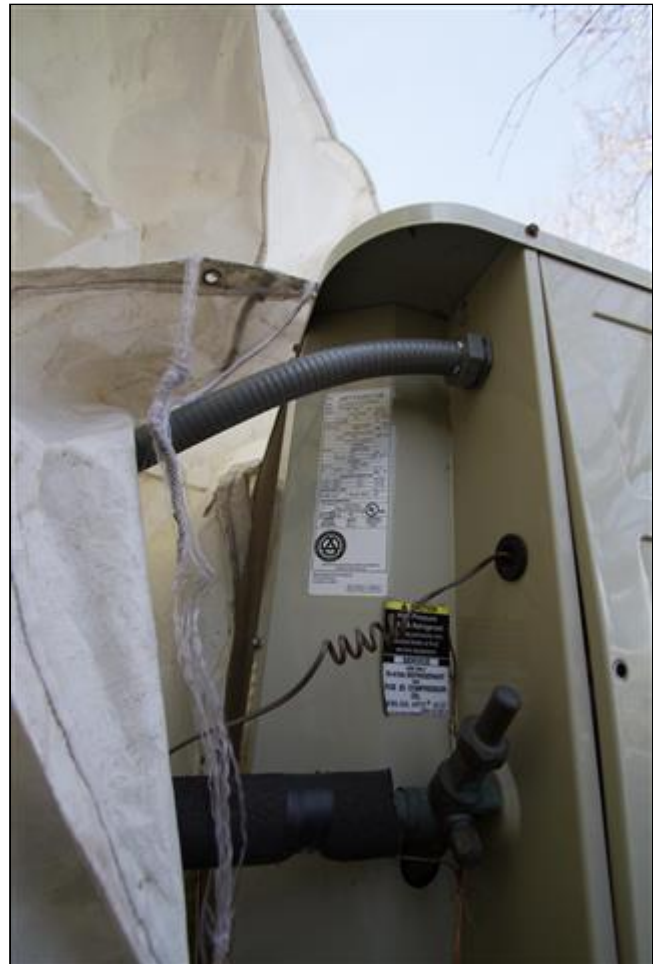
9.8 (1) CONDESING UNIT: We did not test the air conditioner as the temperature was below 65F. We did visually inspect the unit and it appeared in good working order. Annually, and prior to the cooling season, the condenser unit should be inspected to make sure that there is no excess of debris in the unit and that the insulation around the hoses is intact. Every few years, or as needed, a trained HVAC technician can inspect and service the condensing unit. Protecting the unit during winter months is highly recommended. NEVER OPPERATE THE AIR CONDITIONER IF THE OUTSIDE TEMPERATURE IS BELOW 65F.

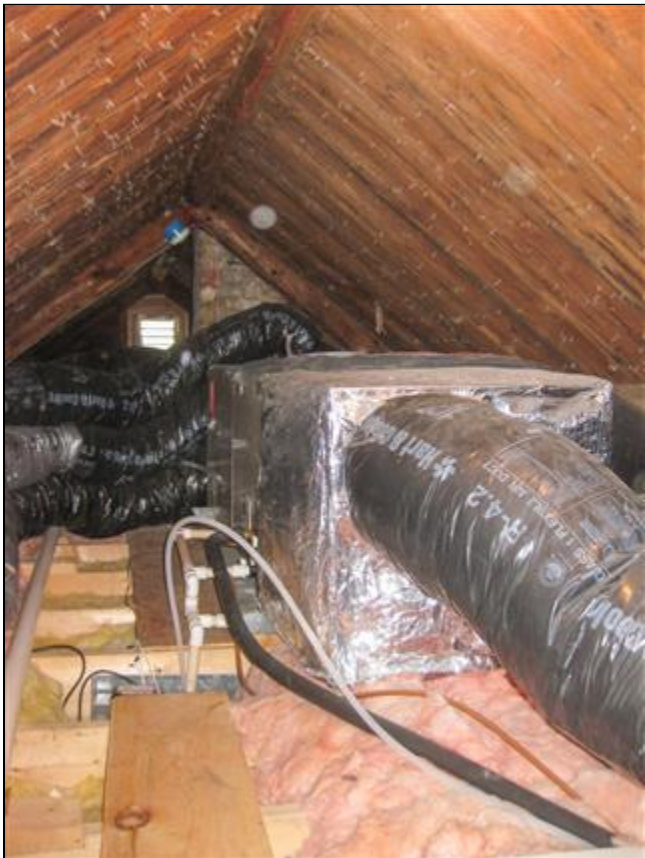
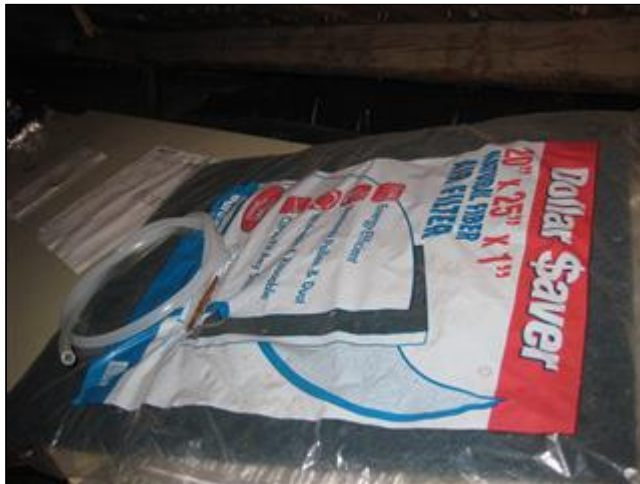
9.8 (2) AIR CONDITIONER: The a/c air handler is located in the attic and appears to be properly equip with flood pan and condensate piping. An annual service report was observed on the unit.

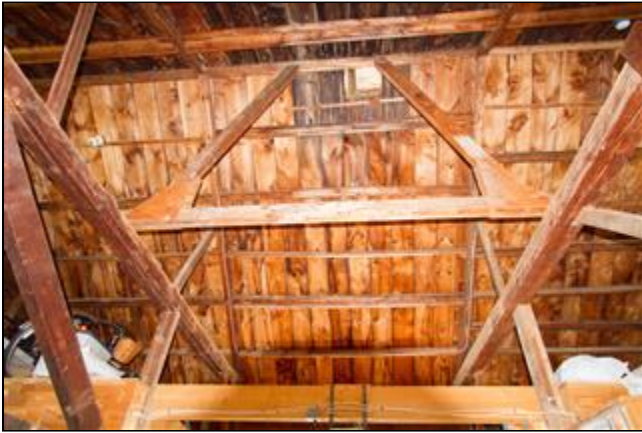
10.3 Picture 1 Roof Structure

10.3 ROOF STRUCTURE: The roof is build similarly to the main house- post and beam

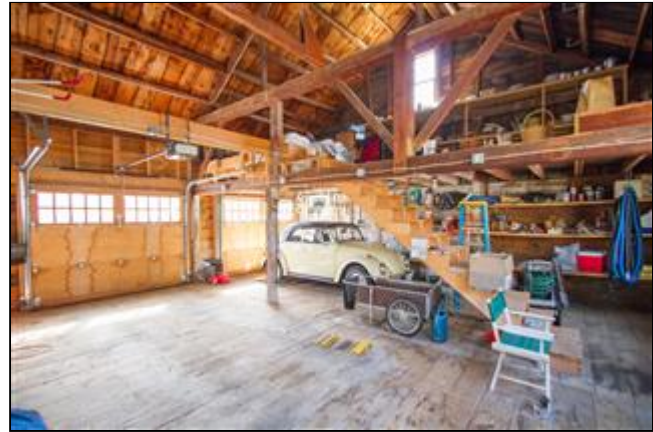
10.4 Picture 2 Wall Structure

10.4 WALLS: The structure is post and beam so the structure is supported by the beams. The areas between beams are filled with wood framing and barn board. Signs of several repairs...it is over 100 years old so this is to be expected.

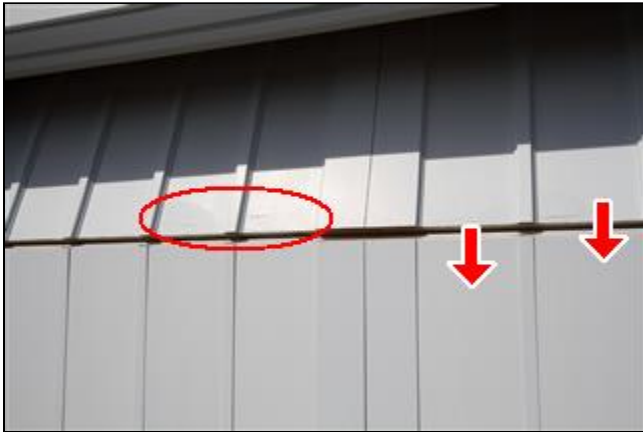
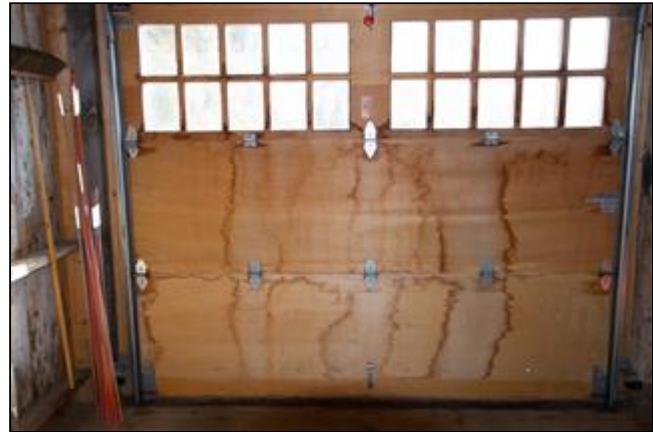
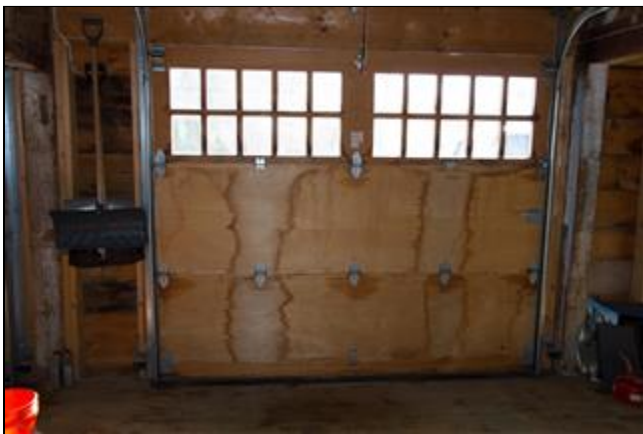
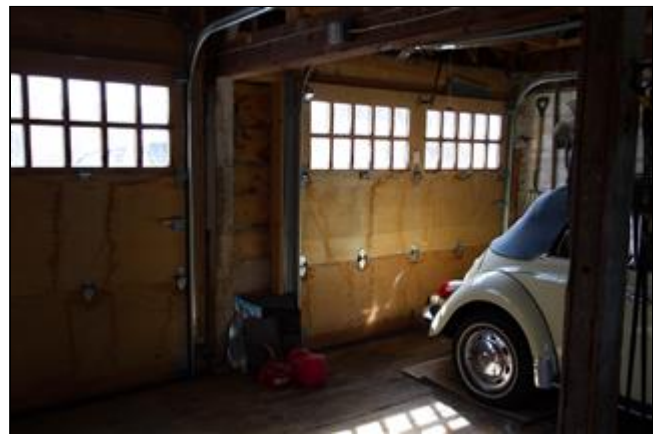
10.6 (1) 3-BAY GARAGE DOORS: These doors are wooden insulated panel type doors. The garage doors have staining from driving rain or leaking. There are signs of minimal rot on the exterior. The lower panels appear to have been clad with PVC sheet stock-a repair to damaged wood I would assume. Monitor and repair as needed.
