Inspection Report

Property Address:
190 Fay Way
Rye Beach New Hampshire 03871

DBC Home Inspections

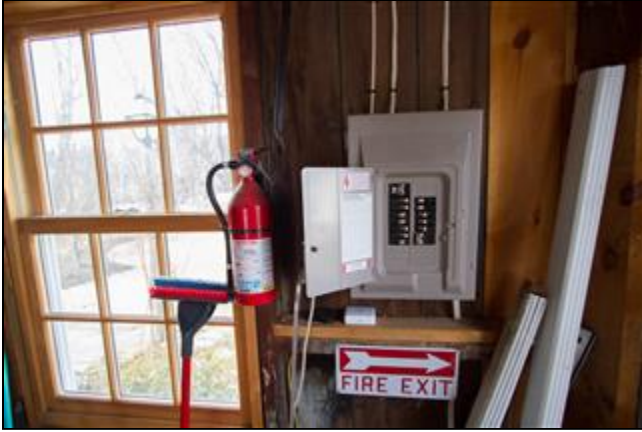
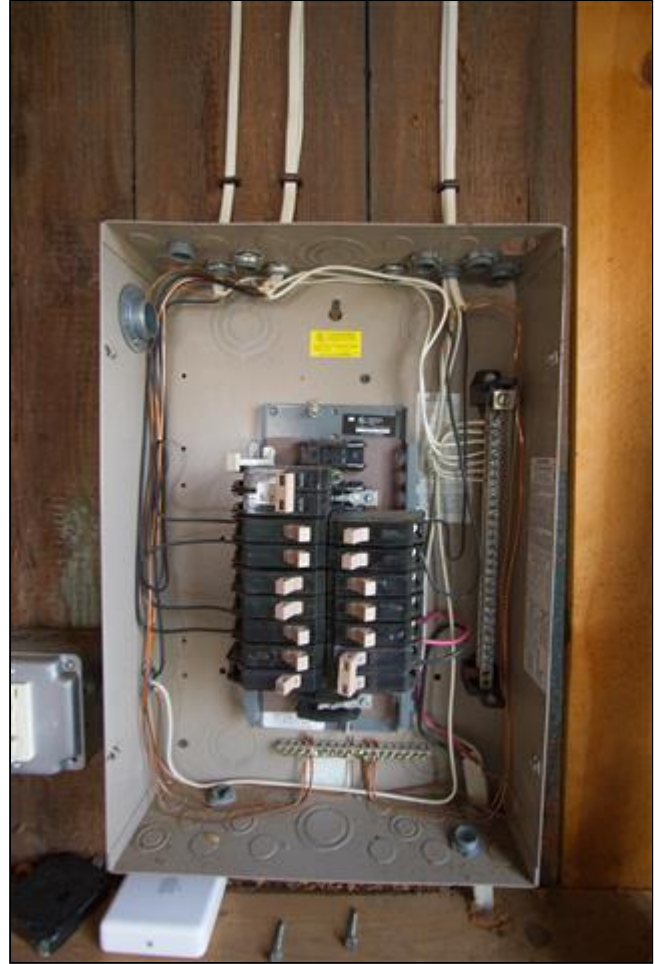
10.8 PANEL: It appears as this panel was once the panel for the main house. The panel is in good shape and operating currently as a sub panel for the barn.

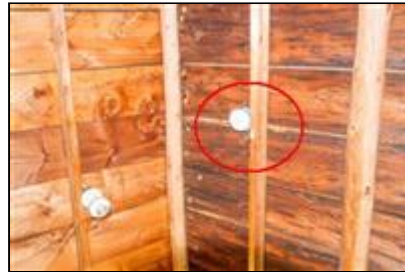
10.10 Picture 1 Smoke Detector

10.10 SMOKE DETECTOR:
Smoke/Fire detector present.

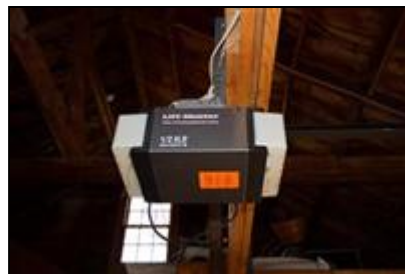
10.11 Picture 1 Garage Door Operator

10.11 GARAGE DOOR OPNERS:
Each of the three bays have a garage door opener that operate correctly & safely.
